Reprinted with permission from the
December 2015 issue of *Claims* magazine

Engine Damage: Impact or Mechanical Failure

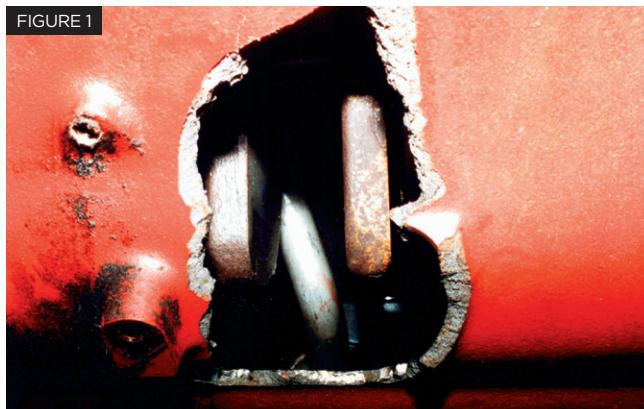
Claims handlers are often charged with determining if an automotive engine failure is a result of an impact with an object or a result of an internal problem that caused the damage, typically called mechanical failure. Many policies are written to extend coverage when the vehicle impacts an object causing damage to the engine, while coverage is denied if an internal malfunction causes damage to the engine. **Figure 1** is a view of a penetration in an engine block that was claimed to be caused by an external object striking the engine.

Going back to **Figure 1**, the penetration is at the engine block near a connecting rod in an area that would be difficult for a road object to penetrate without leaving any other evidence of impact, such as scraping. The shape of the penetration presents fracture surfaces that angle outward, which is characteristic of a penetration that came from within the engine.

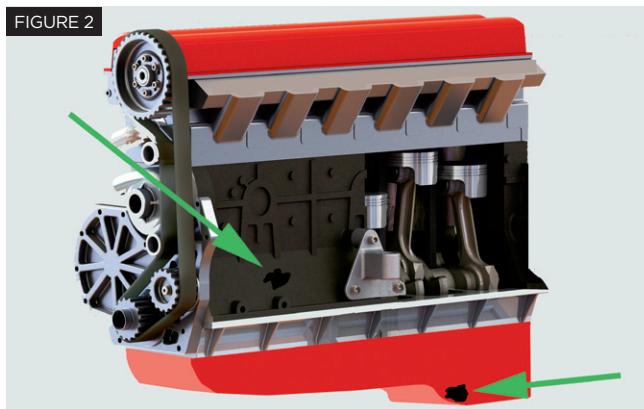
Figure 2 is a view of a typical engine. Penetrations in the block area shown by the upper arrow are typically the result of an internal engine problem such as connecting rod or piston failure.

The engine block is higher up in the vehicle engine compartment and less vulnerable to penetration by an object found on the road. A penetration at the oil pan can be a result of impact with a road object as this is an area that is low and close to the road on a vehicle.

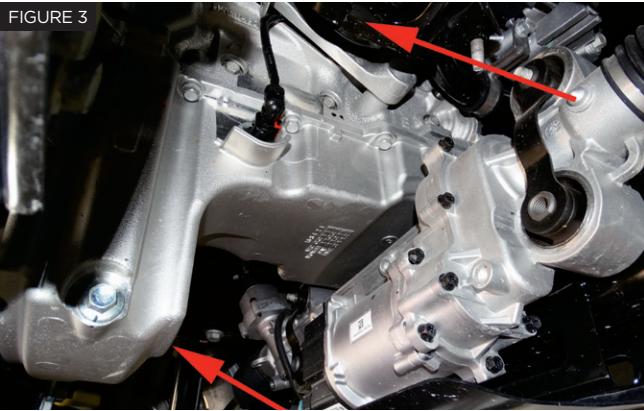
FIGURE 3

Figure 3 is a view of an engine mounted in longitudinal fashion — the crankshaft is parallel to the long axis of the vehicle. The lower arrow points to the oil pan which is more vulnerable to road object impact than the engine block as indicated by the upper arrow.

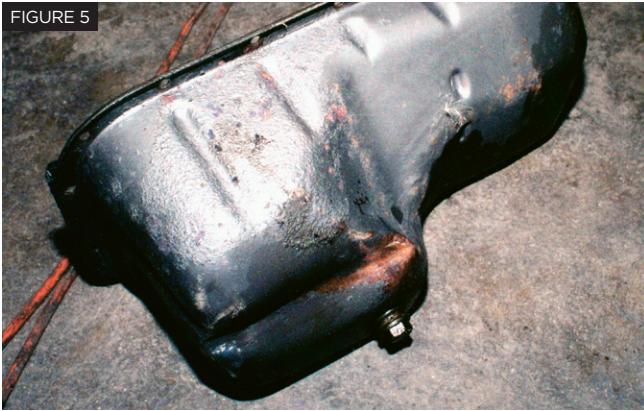
FIGURE 5

Figure 5 is a view of an oil pan showing impact damage to the lower portion — a crease in the metal. This did not cause a leak or interfere with any engine components and did not cause the engine failure. Oil analysis showed high internal metallic

contact, suggesting that the failure was a result of engine wear brought on by poor maintenance.

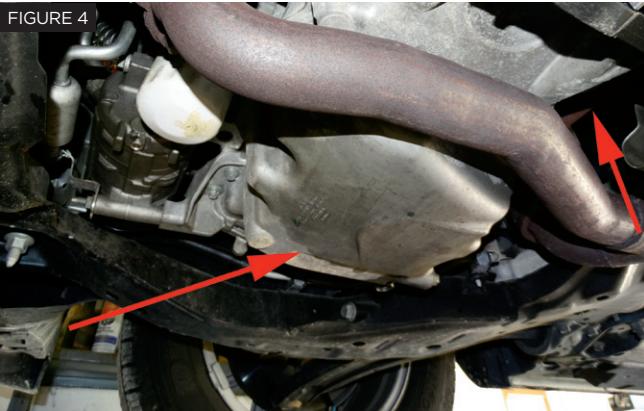
FIGURE 4

Figure 4 shows a transverse mounted engine — the engine crankshaft is perpendicular to the long axis of the vehicle. The lower arrow points to the oil pan which is vulnerable to road object impact, while the engine block is well protected as indicated by the upper, right arrow.

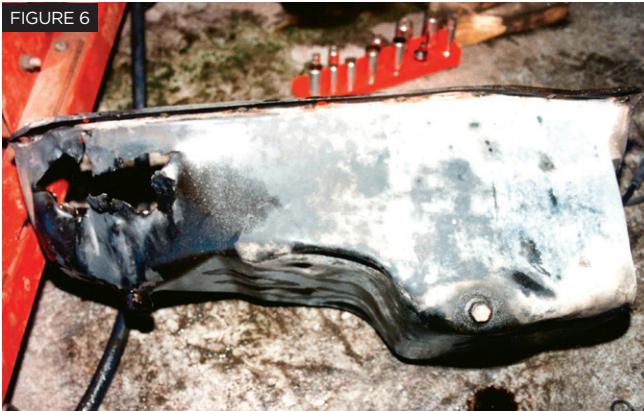
FIGURE 6

Figure 6 shows an oil pan that sustained an impact with an external object, causing a severe inward deformation of the front of the oil pan. The deformation interfered with the crankshaft, which wore an opening in the pan, expelling oil and causing loss of oil pressure in the engine, leading to a failure. Some oil pans on vehicles with low clearance are vulnerable to road object impact. When this occurs, engine oil is expelled, which can be detected when the low oil pressure warning occurs on the instrument panel. There are circumstances when the penetration or deformation occurs from a road object where there is relatively little damage to the engine, if it is shut off immediately. If the vehicle continues to be driven after such an event, severe damage to the engine from a lack of oil pressure may occur.
