# Subrogation Matters: Fireplace Installation and Construction Defects

By Charles C. Roberts, Jr., Ph.D., P.E.

## Establishing Fire Cause and Origin Post-Loss

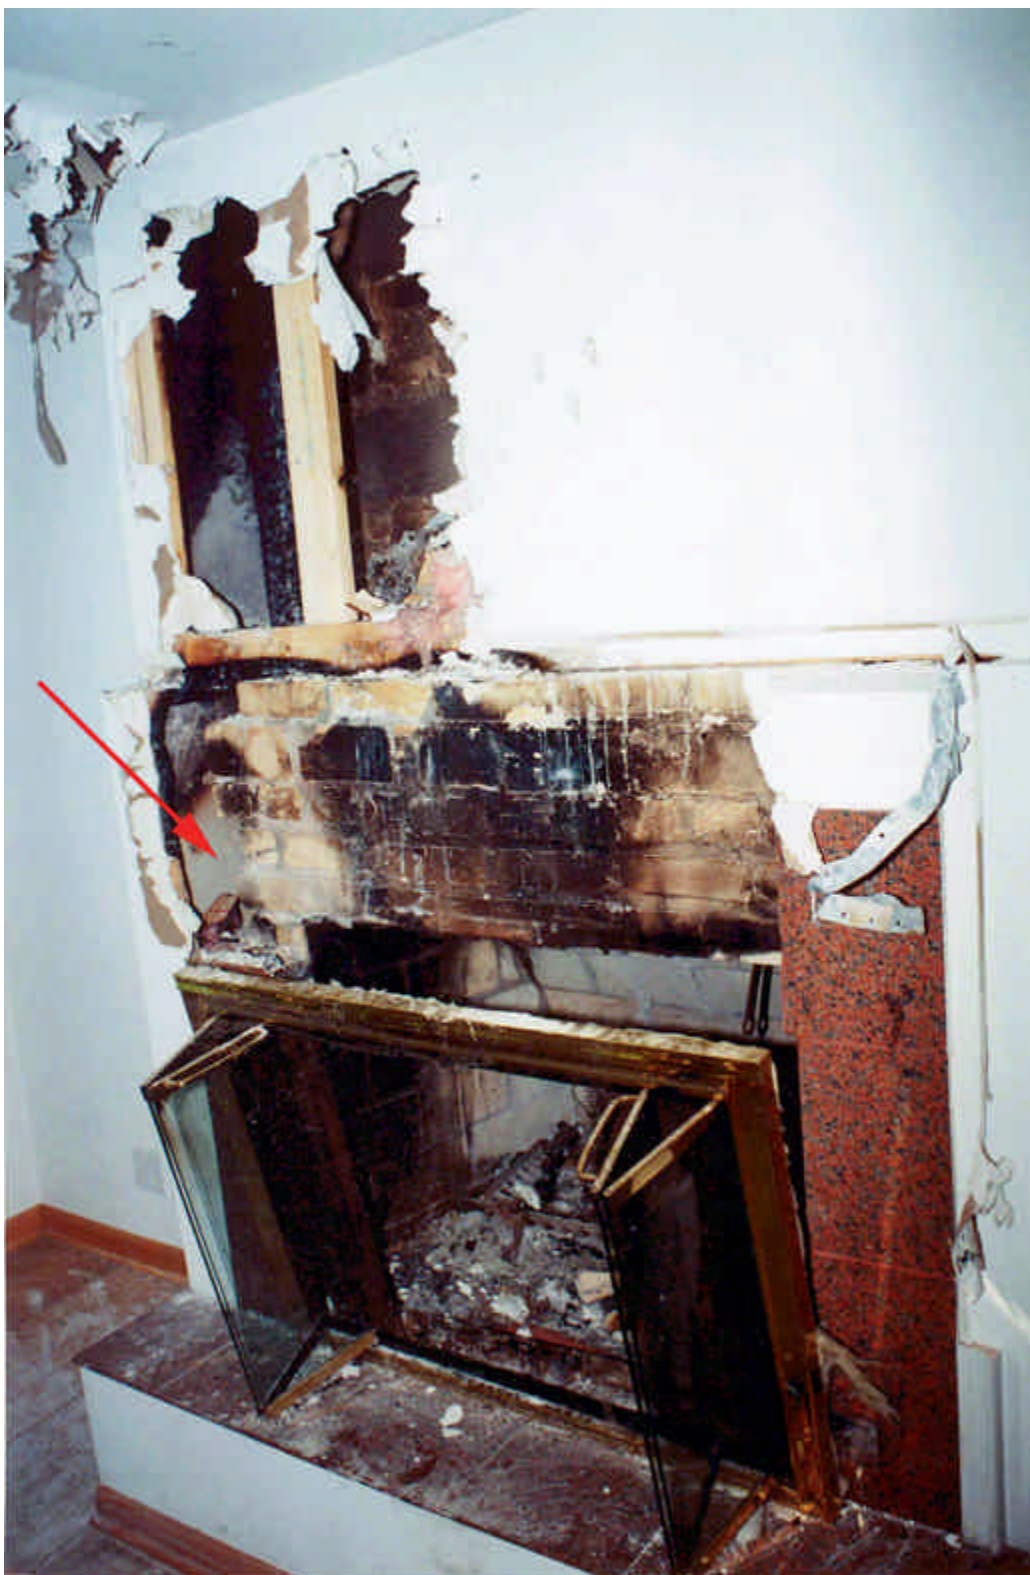
Figure 2

**Figure 2** is a view of a masonry fireplace involved in a home fire loss. Burn patterns suggest a fire origin to the left of the fireplace (refer to the arrow), where a gap in the masonry liner of the firebox was discovered. Over time, hot gases from the fire dried out the wood framing, lowering the ignition temperature of the wood (pyrophoric decomposition of wood), thus starting a fire. This was a result of insufficient mortar in a joint. This type of fire causation can occur with a newly constructed fireplace or an older one, with the governing factor being the frequency and severity of impingement of hot gases on the wood framing.

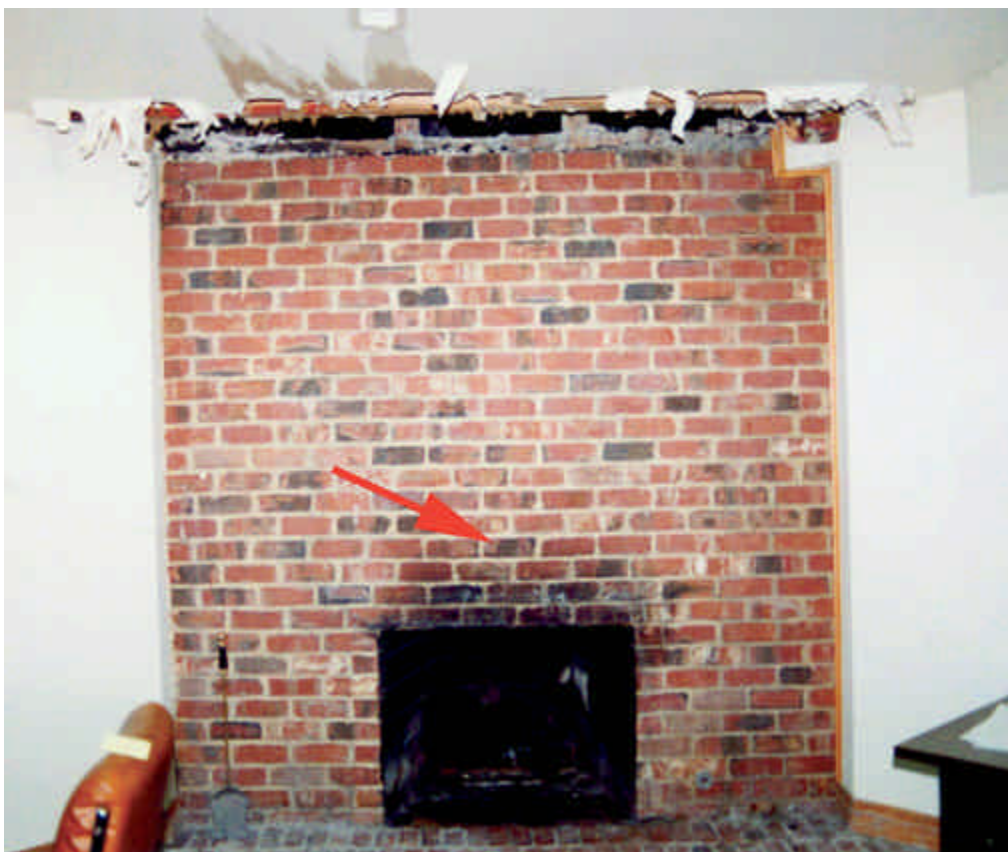
Figure 3

**Figure 3** shows a masonry fireplace after a fire that badly damaged the framing behind the masonry, above the lintel. Burn pattern analysis indicated the fire origin was in the framing behind the brickwork (as shown by the arrow), with the fire developing upward into the second floor framing. Investigators discovered a construction defect: the seal between the firebox and lintel was non-existent and thus allowed hot gases to escape upward into the framing cavity above.

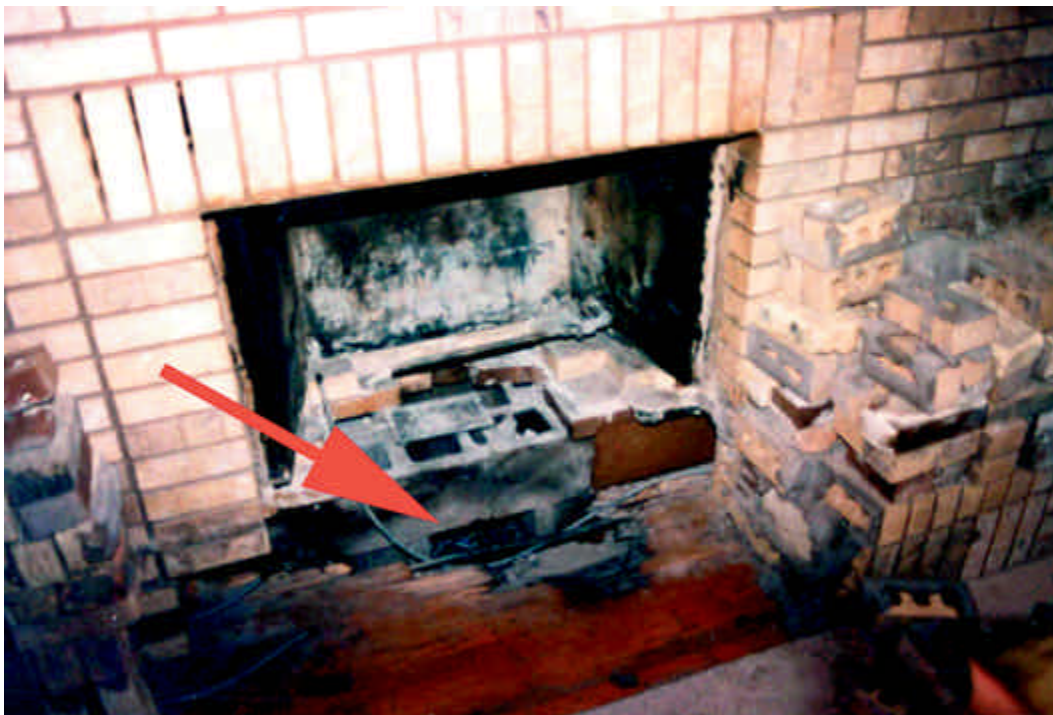
Figure 4

**Figure 4** is a view of a masonry fireplace in an older home where the fireplace was rarely used by the previous owner. The new owners started using the fireplace extensively, and it was not long before a blaze developed in the framing under the hearth. The owner had shoveled hot ash through the ash door, down into the ash pit. Investigation of the ash pit later revealed there was no ash dump below, but merely the concrete block used to support the fireplace. There was no cleanout door inside or outside the home. The hot ash had piled up, eventually igniting the wood framework nearby. The adjuster should note that the improper ash pit is clearly a construction defect.

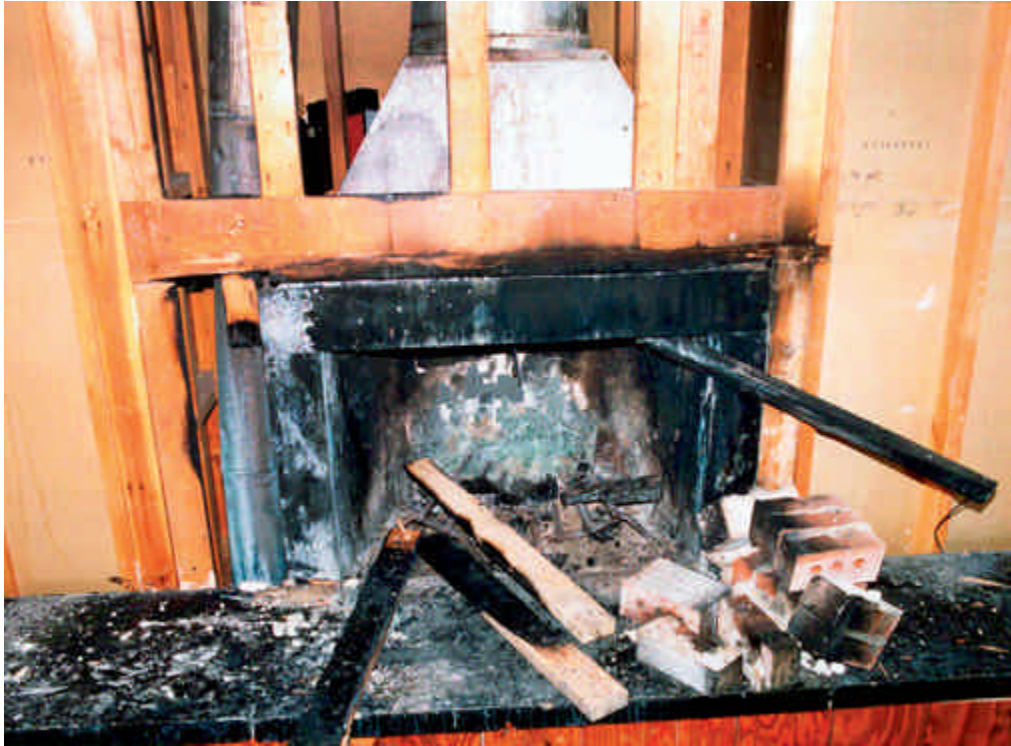
Figure 5

In **Figure 5**, damage to the fireplace and home results from over- fueling the fireplace (too much wood). The condition was aggravated by the lack of a protective screen, resulting in heat transfer to combustible materials, causing fire. This is a misuse of the fireplace.

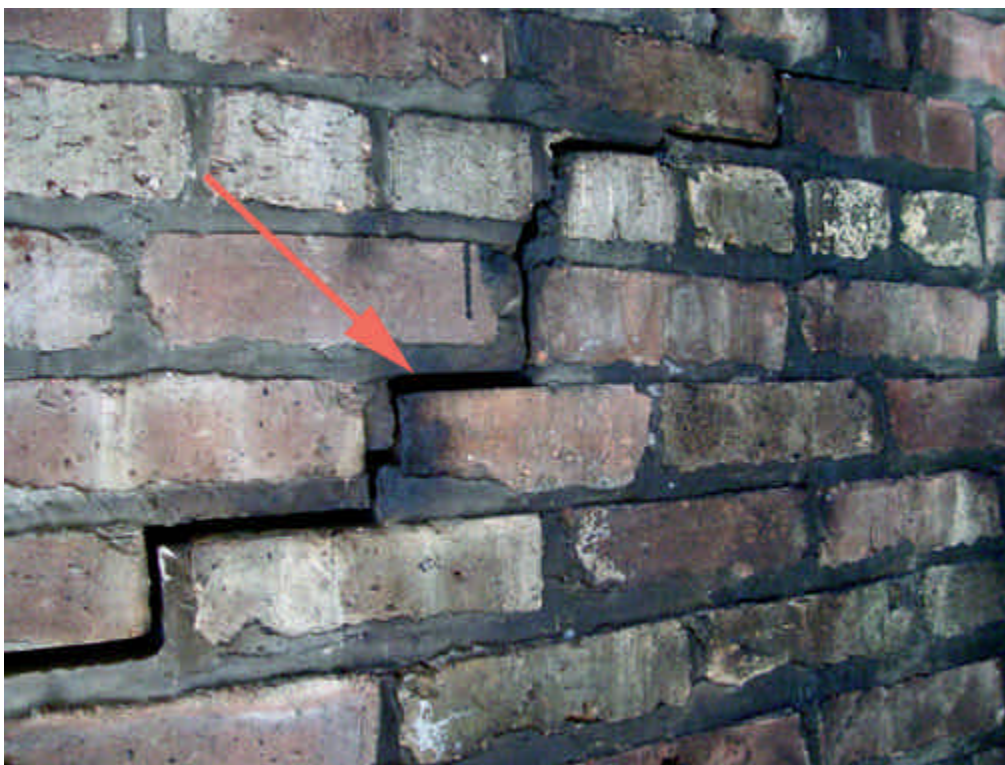
Figure 6

Masonry fireplaces may weigh several tons, requiring a solid foundation. In **Figure 6**, settling of the foundation of a newly constructed fireplace caused a severe crack to propagate into the firebox area, exposing wood framing to high temperatures, resulting in a fire. The root cause is improper construction of the foundation, which was not sufficient to support the weight of the fireplace.

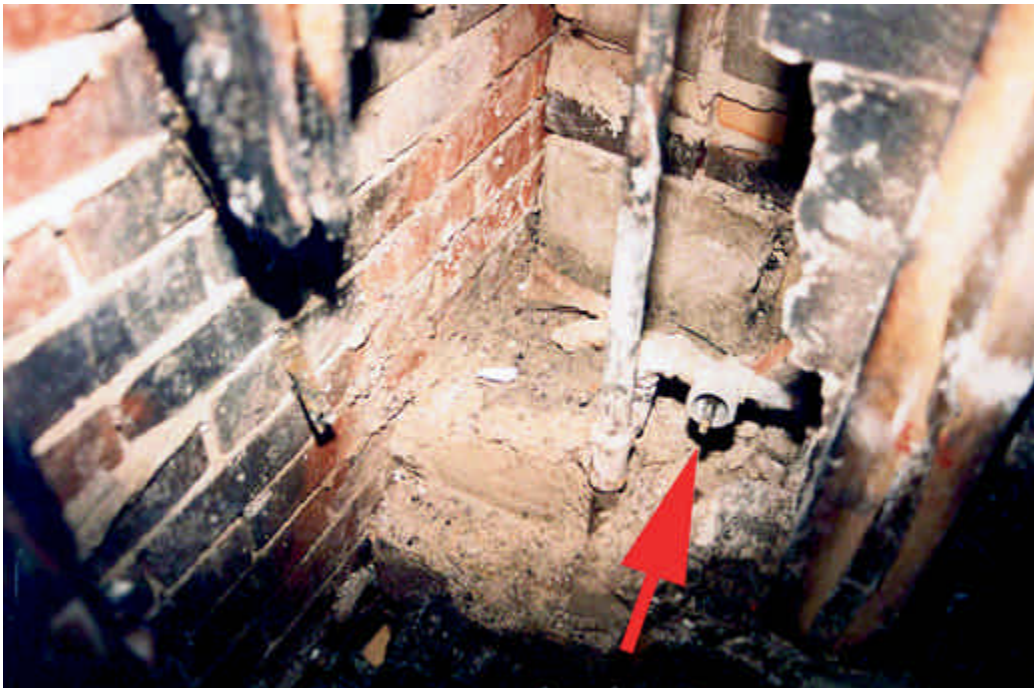
Figure 7

In **Figure 7**, a fire origin was discovered around a natural gas valve used to control the burner in the fireplace. Testing indicated the gas valve stem seal was leaking gas, which eventually ignited, causing a fire in the framing next to the fireplace. It should be noted that when the valve was shut, the stem seal was not exposed to gas. Consequently, an explosion did not result from leaking gas. The stem seal only leaked when the valve was turned on. An improperly installed stem seal was found to be the cause of leakage.

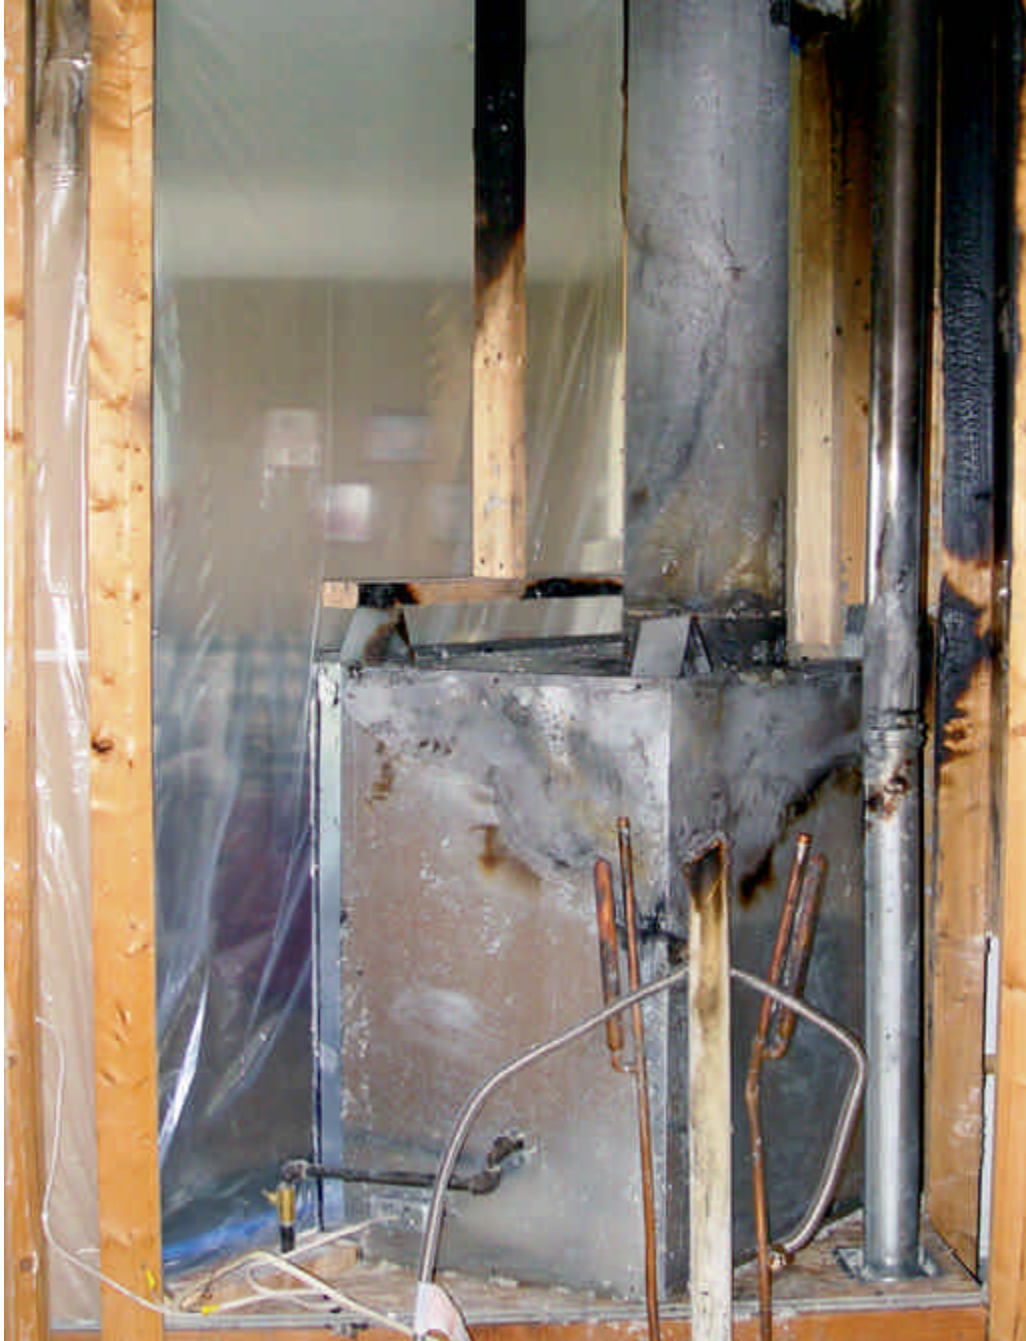
Figure 8

**Figure 8** shows a prefabricated fireplace that was nearly covered with cellulose insulation prior to the fire. The insulation caused a high firebox temperature, resulting in the ignition of either the cellulose insulation or the neighboring wood chase framing. It should be noted that fire retardants are normally applied to cellulose insulation, but that still burns under certain conditions. The manufacturer of the prefabricated fireplace requires air flow around the firebox for proper operation. In this case, improper application of insulation caused the fire (an installation defect).

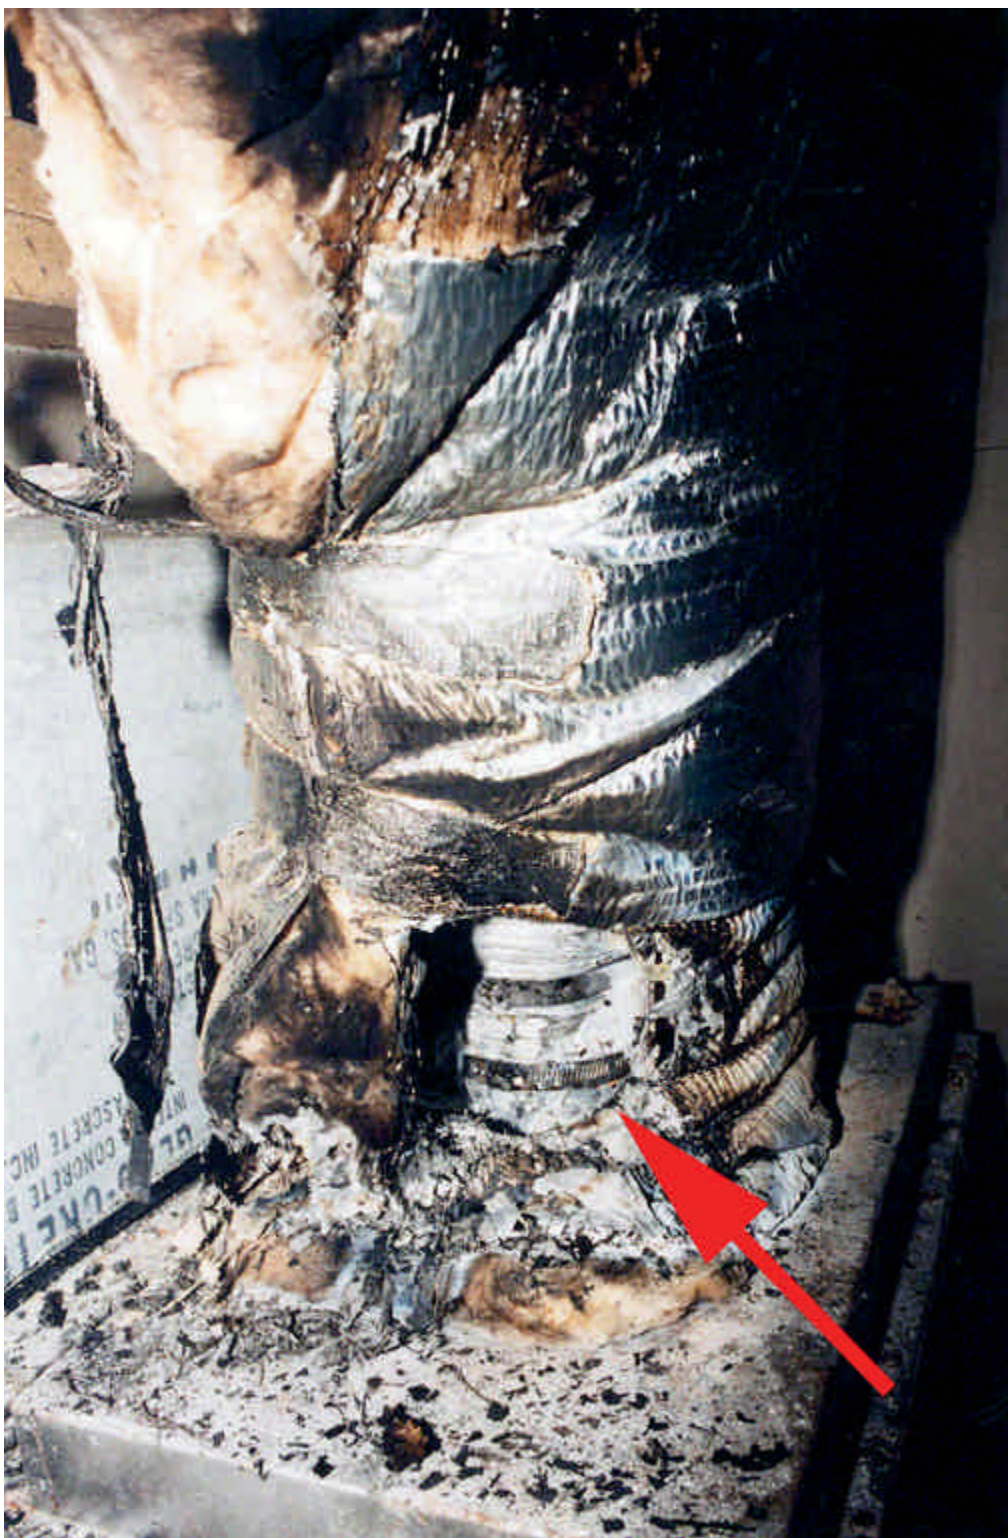
Figure 9

**Figure 9** shows the insulation blanket wrapped around the lower flue on a prefabricated fireplace. A repairman was adjusting the clamps at the base of the flue and completed the work without restoring the thermal insulation blanket around the base of the flue. The large opening in the insulation (see arrow) allowed sufficient heat transfer to ignite construction debris on top of the firebox, causing a blaze. Therefore, improper workmanship was the underlying cause of the fire in this case.
