# Claims<sup>®</sup>

# Improper Automotive Electrical Wiring

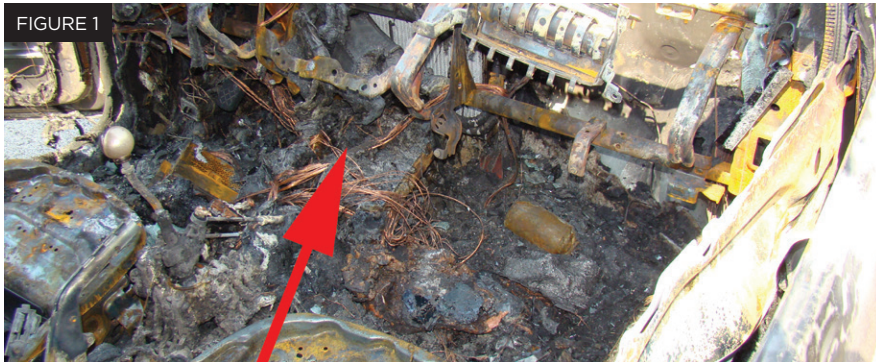
Figure 1 is a view of the occupant compartment near the origin of the fire. The most severely damaged area was at the instrument panel in the vicinity of a stereo system (arrow).

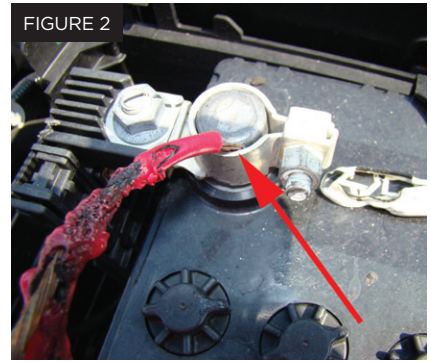
Since the insured observed a glowing wire in the engine compartment, the wiring in that area was inspected. A power wire was found attached to a battery post as shown in Figure 2. The wire insulation was badly burned, consistent with excessive current flow, which could cause a fire. The battery was in good condition.

It is apparent that the installation of the stereo system was not performed in a professional manner. The connection to the battery using the battery clamp is not proper. A wire termination should be used and connected to an auxiliary terminal in the fuse block of the vehicle if possible.

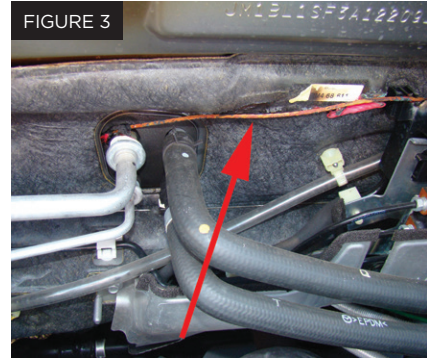
The arrow in Figure 3 shows the burned wire routed through the bulkhead at an air conditioner tube penetration. The wire is badly burned, but the engine compartment was undamaged, meaning that a failure in the occupant compartment caused the excessive current and not any failure in the engine compartment.

It is also good practice to use a fuse or resettable breaker in the power wire circuit to provide protection in case a fault occurs. Finally, the routing of the wire over a sharp metal structural member is improper, since it often results in wire chaffing and an electrical fault. This particular installation is deficient, suggesting that the installer is a possible target of subrogation. ❏

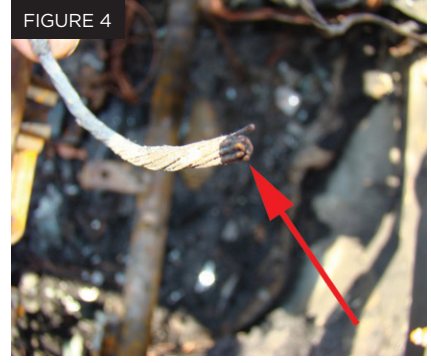
Tracing the wire through the firewall resulted in the discovery of the melted end (as shown in Figure 4) near a stereo system, mounted under the instrument panel. The melted conductor strands at the end of the wire as indicated by the arrow were ev-

idence of an electrical fault (short circuit). This wire was routed in an area where chaffing of the protective wire insulation was likely causing a short circuit, melting of the conductor and ignition of material in the instrument panel near the stereo.

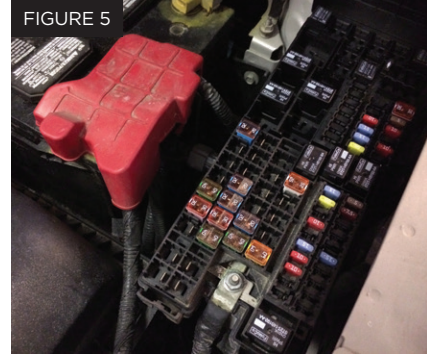
Figure 5 is a view of a typical fuse/re-relay block in a vehicle. Many of these fuse blocks have unused terminals explicitly for the installation of aftermarket electrical equipment.
