Claims

Reprinted with permission
from the May 2017 issue
of *Claims* magazine

Improper Automotive Electrical Wiring

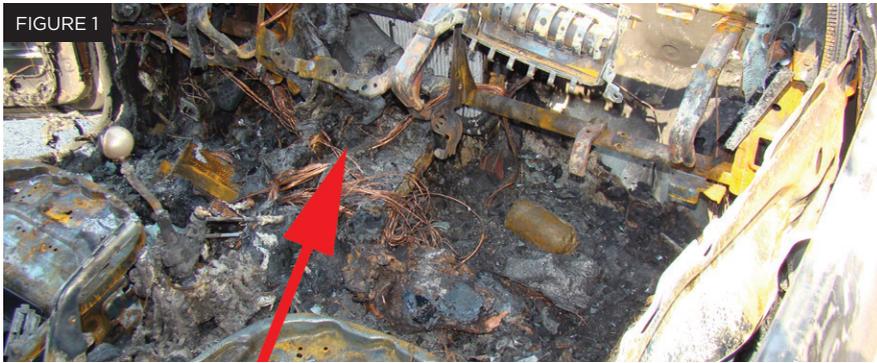
While operating his vehicle, the insured smelled smoke, stopped the vehicle and opened the hood to assess the situation. He noticed a glowing wire generating smoke. Suddenly, a fire developed in the instrument panel of the occupant compartment, causing a total loss of the vehicle.

Figure 1 is a view of the occupant compartment near the origin of the fire. The most severely damaged area was at the instrument panel in the vicinity of a stereo system (arrow).

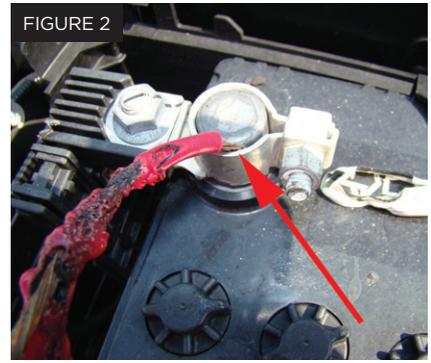
Since the insured observed a glowing wire in the engine compartment, the wiring in that area was inspected. A power wire was found attached to a battery post as shown in Figure 2. The wire insulation was badly burned, consistent with excessive current flow, which could cause a fire. The battery was in good condition.

It is apparent that the installation of the stereo system was not performed in a professional manner. The connection to the battery using the battery clamp is not proper. A wire termination should be used and connected to an auxiliary terminal in the fuse block of the vehicle if possible.

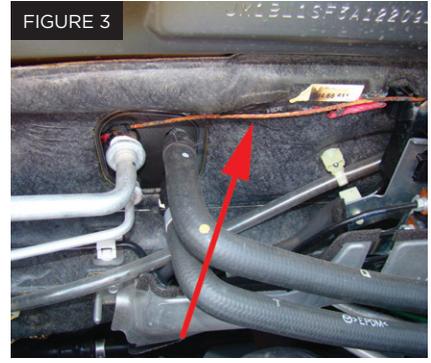
The arrow in Figure 3 shows the burned wire routed through the bulkhead at an air conditioner tube penetration. The wire is badly burned, but the engine compartment was undamaged, meaning that a failure in the occupant compartment caused the excessive current and not any failure in the engine compartment.

It is also good practice to use a fuse or resettable breaker in the power wire circuit to provide protection in case a fault occurs. Finally, the routing of the wire over a sharp metal structural member is improper, since it often results in wire chaffing and an electrical fault. This particular installation is deficient, suggesting that the installer is a possible target of subrogation. ❏

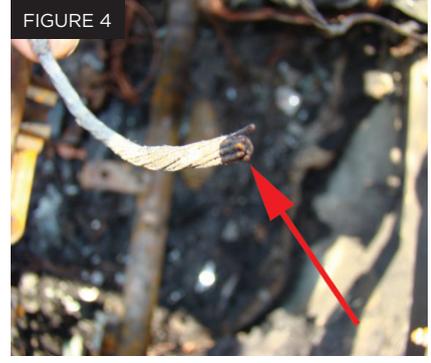
Tracing the wire through the firewall resulted in the discovery of the melted end (as shown in Figure 4) near a stereo system, mounted under the instrument panel. The melted conductor strands at the end of the wire as indicated by the arrow were ev-

idence of an electrical fault (short circuit). This wire was routed in an area where chaffing of the protective wire insulation was likely causing a short circuit, melting of the conductor and ignition of material in the instrument panel near the stereo.

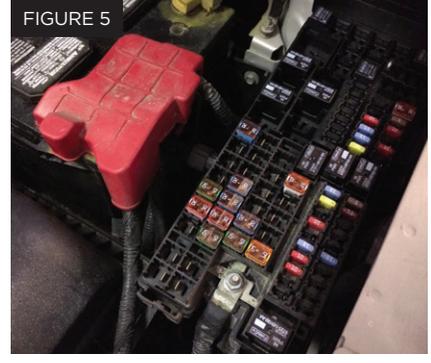
Figure 5 is a view of a typical fuse/re-relay block in a vehicle. Many of these fuse blocks have unused terminals explicitly for the installation of aftermarket electrical equipment.
