Claims[®]

Improper Automotive Electrical Wiring

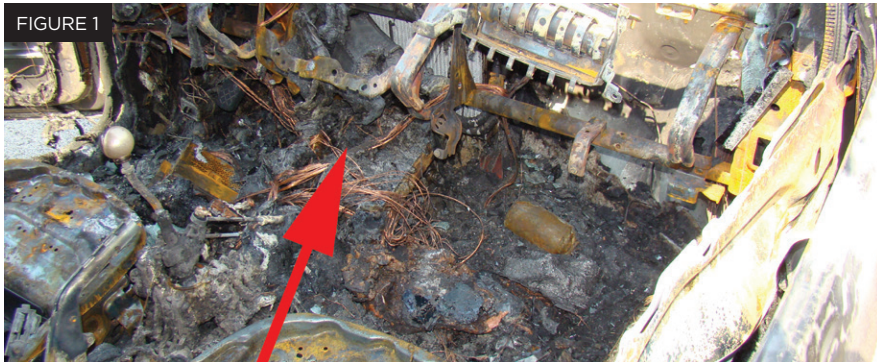
Figure 1 is a view of the occupant compartment near the origin of the fire. The most severely damaged area was at the instrument panel in the vicinity of a stereo system (arrow).
