Failure Analysis of an Irrigation System

Charles C. Roberts, Jr.
Ph.D., P.E.
www.croberts.com

A Case Study

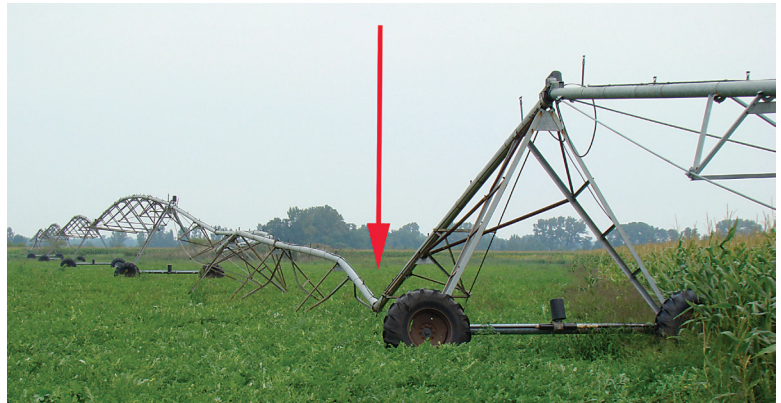
Figure 1 is a view of a typical center pivot agricultural irrigation system, which is essentially a water pipe with drive wheels that rotates about a fixed pylon. The pipe is supported with wire cables attached to struts that hold the pipe in a curved shape. Equally spaced are electric, motor driven, wheels that turn slowly allowing the system to walk around the pivot, delivering water to the crop. In **Figure 1**, a failure of the water delivery pipe has occurred as indicated by the arrow. This has caused the pipe and support structure to collapse, making irrigation impossible.

Fig. 1 — Typical center pivot agricultural irrigation system showing a failure of the water delivery pipe.

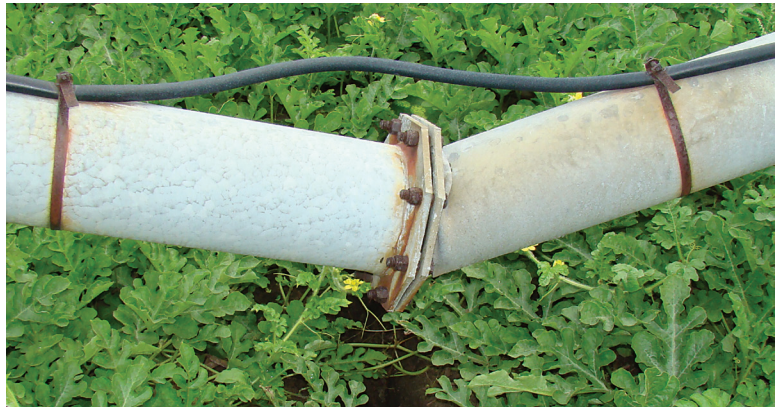
Figure 2 is a side view of the irrigation pipe at the area where the failure occurred. This is an eight bolt flange. Rust patterns suggest that this flange connection had been leaking over time.

Fig. 2 — side view of the irrigation pipe at the area where the failure occurred.

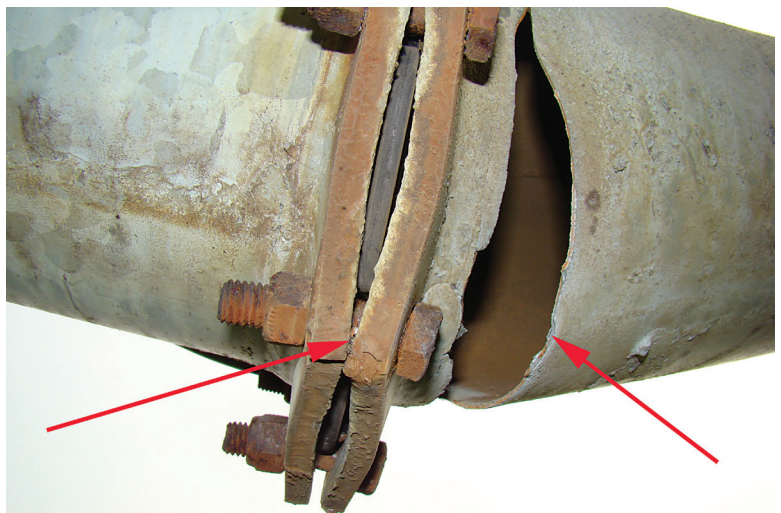
Figure 3 is a close-up of the failure origin. There was a ductile fracture at the lower area of the pipe with an origin approximately at the right arrow, just outside the weld fillet. The left arrow points to pipe flanges that are severely deformed and nearly touching at the bolt locations. The bending of the flanges is a result of excessive bolt compression around a gasket that only seats in the circular section of the pipe. Since the bolts are not equipped with cylindrical spacers, there is no limitation as to the degree of travel of the nut along the bolt. This has caused excessive stress in the vicinity of the right arrow, initiating a crack and final fracture.

When flange connections such as the one shown in **Figure 3** leak, the tendency is to tighten the connection hoping that further compression of the gasket will stop the leak. In this case, excessive torque has caused the bolt shafts to bend as seen in **Figure 3**. It is not clear that the deformed flanges actually stopped the leak since it appears that a gap has developed in the flange to gasket area between bolts.

An instruction to limit the flange bolt torque in the installation manual would also be helpful, but the spacers would surely prevent flange deformation from excessive bolt torque. In this case, the root cause of the failure is excessive torque being applied to the flange bolts.

Fig. 3 — Close-up of the failure origin showing ductile fracture at the lower area of the pipe with an origin approximately at the right arrow, just outside the weld fillet.

A better design here would be to install spacers in order to limit the amount of bolt compression delivered to the flanges so they remain planar and do not strain the weld fillet area that attaches the flange to the pipe. If tightening a flange set up with spacers does not stop the leak, then the gasket should be replaced.
