Lumber Defects and Roof Frame Failures

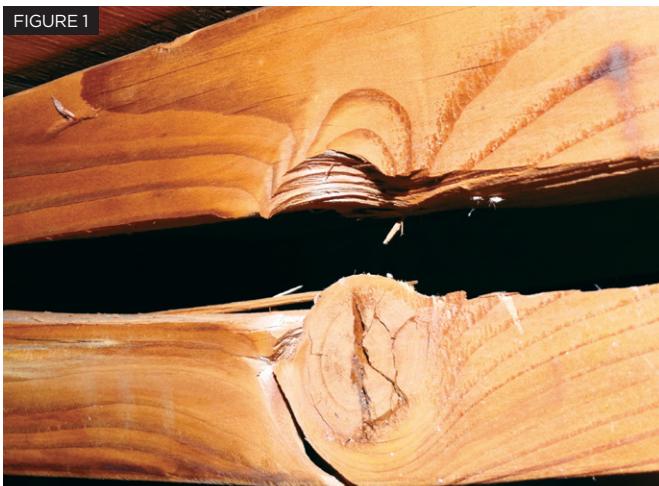
FIGURE 1

Figure 1 shows a roof rafter failure brought on by a large knot that encompassed about half of the cross section of the board. The knot extended from the center all the way to the lower edge or tension side of the joist. The knot had not adhered well to the surrounding wood and a crack developed along the circumference of the knot. Since the crack entered the tension side of the joist, it propagated from the lower edge, resulting in severe reduction in strength. This left half of the cross section of the board supporting the load.

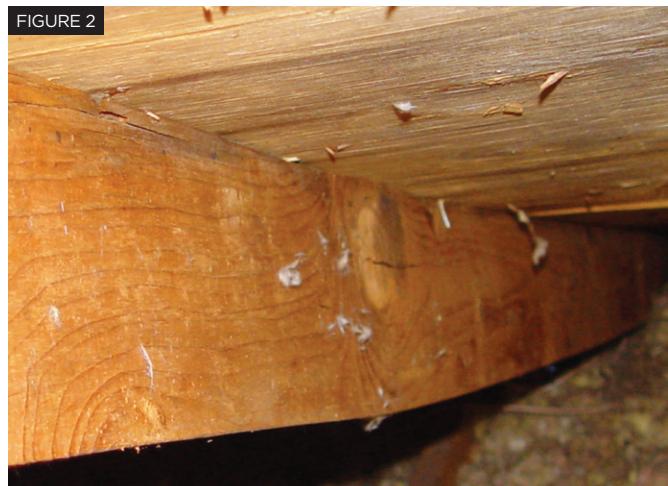
FIGURE 2

Figure 2 shows a roof rafter with a large knot at the upper or compression end of a roof rafter. The knot has reduced the bearing strength of the board and deflection is noted at the location of the knot.

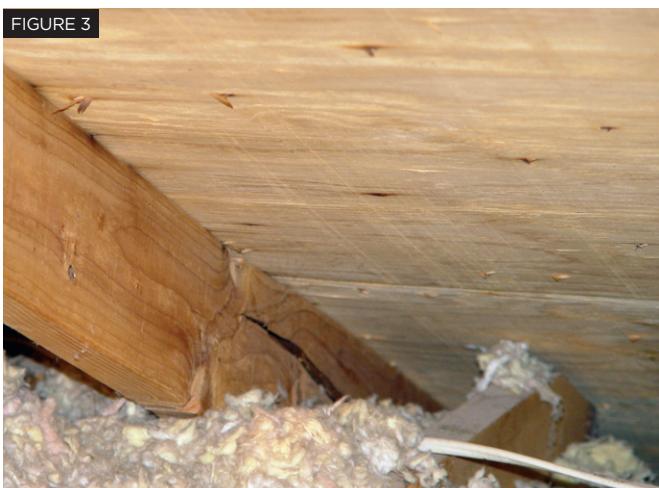
FIGURE 3

Figure 3 shows a pitch pocket at the

end of a roof rafter. This location on the rafter is not subjected to as much bearing stress as the middle of the rafter, but could still result in a failure from compression stresses.

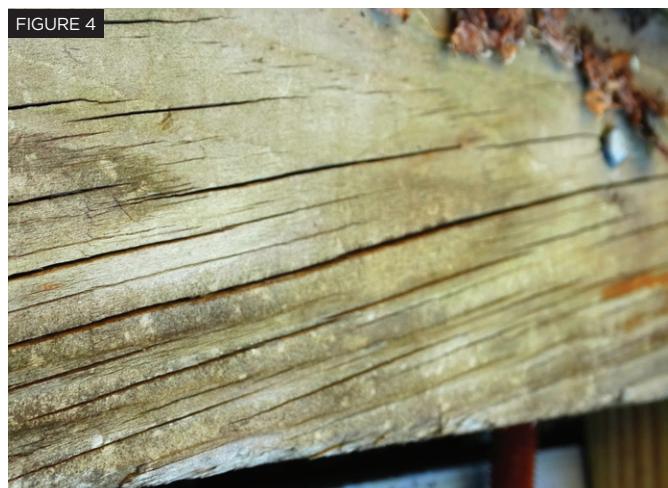
FIGURE 4

In Figure 4, checks have developed into larger cracks that are following the grain. Unfortunately, the grain is not parallel to the long axis of the board and angles inward toward the neutral axis of the joist. The bending stress at the lower part of the joist will eventually drive the crack through the board, causing failure.
