Claims[®]

January
2018

Masonry Wall Cracks: Shelf Angle Failure

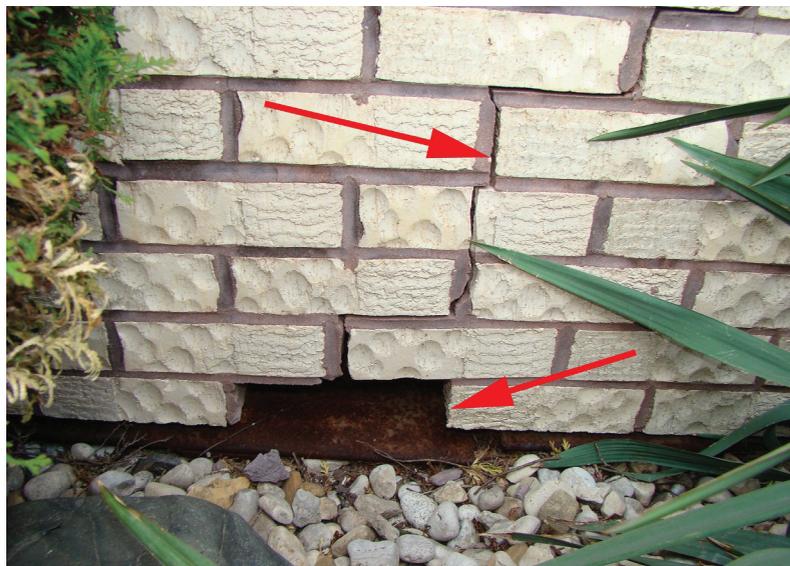
▲ Figure 1

Figure 1 is a view of an insured's brick wall that started cracking near the base (upper arrow). One of the lower masonry units had fallen out, leaving the gap as indicated by the lower arrow. One may suggest that this is typical settling of the foundation wall, but no such downward deflection was noted in the foundation. There appeared to be a problem with the steel support of the brick veneer.

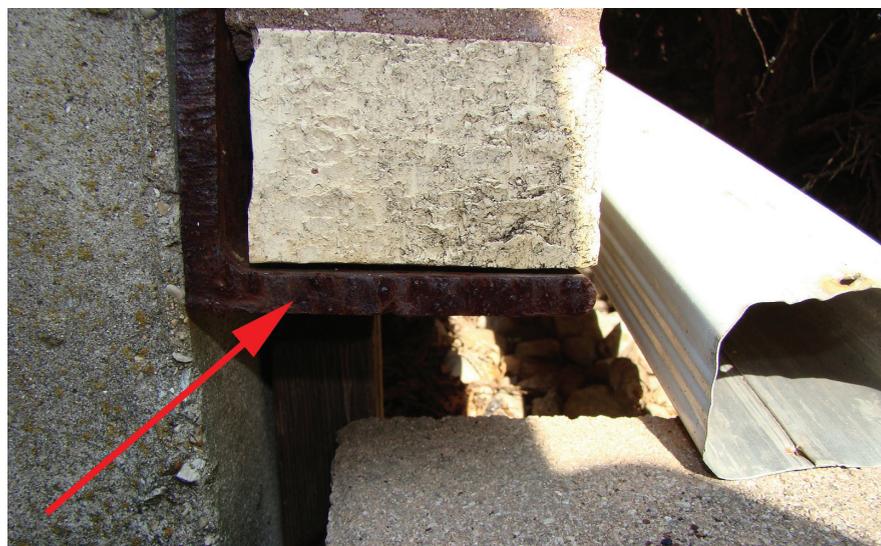
▲ Figure 3

Figure 3 is a view of the angle iron at one of the corners of the insured's ma-

sonry wall. The angle iron was fastened to the foundation wall at the ends only, with no fastening in the middle of the support.

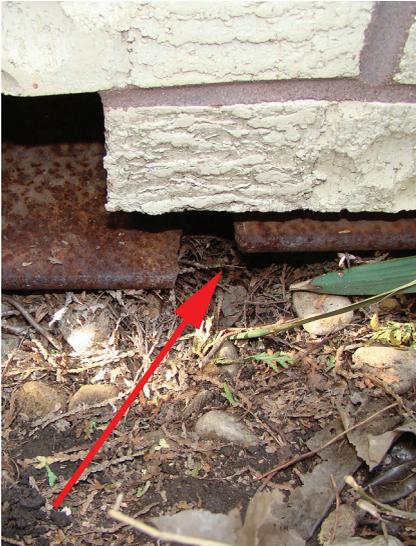
▲ Figure 4

Figure 4 shows the middle of the angle iron which has fractured and dropped down, causing a loss of support of the veneer and the initiation of a large crack in the grouting between masonry units.

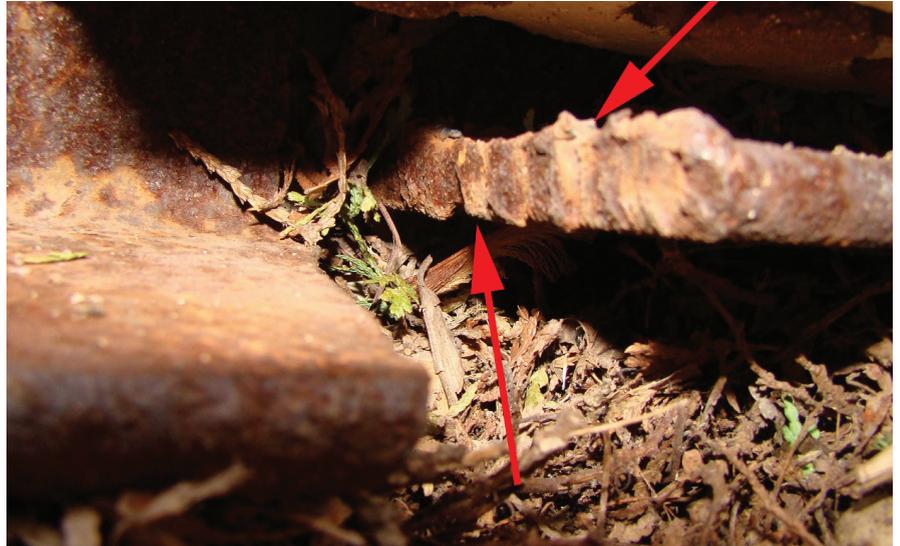
▲ Figure 5

Figure 5 is a close-up of the fracture surface. The lower arrow points to torch cut marks suggesting that this angle iron was cut at one time and then re-welded to form a straight piece. The upper arrow points to a poorly executed weld.

There was evidence of undercuts and lack of penetration, characteristic of a

poor welding technique that resulted in a defective weld. The weld eventually failed, causing loss of support and development of cracks in the veneer. The root cause is a construction defect resulting in

the failure of the shelf angle iron and not settling of the foundation. ❏
