# Masonry Wall Cracks: Shelf Angle Failure

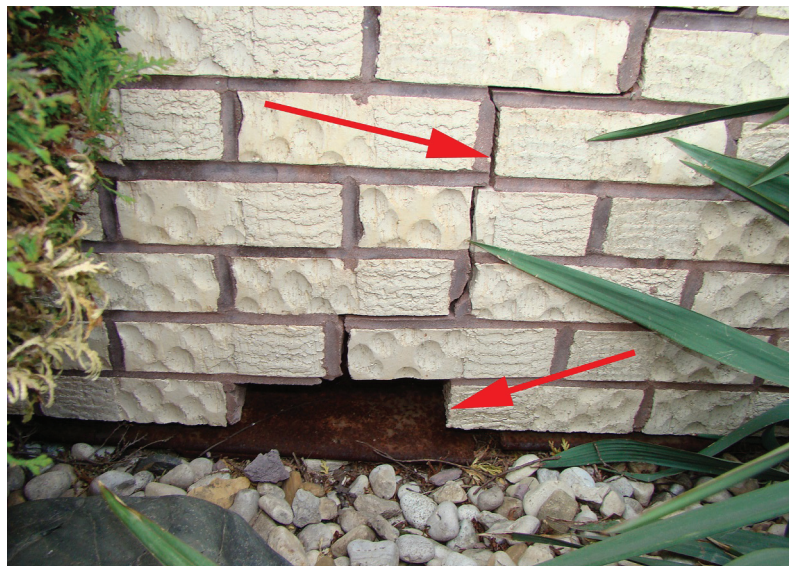
▲ Figure 1

Figure 1 is a view of an insured's brick wall that started cracking near the base (upper arrow). One of the lower masonry units had fallen out, leaving the gap as indicated by the lower arrow. One may suggest that this is typical settling of the foundation wall, but no such downward deflection was noted in the foundation. There appeared to be a problem with the steel support of the brick veneer.

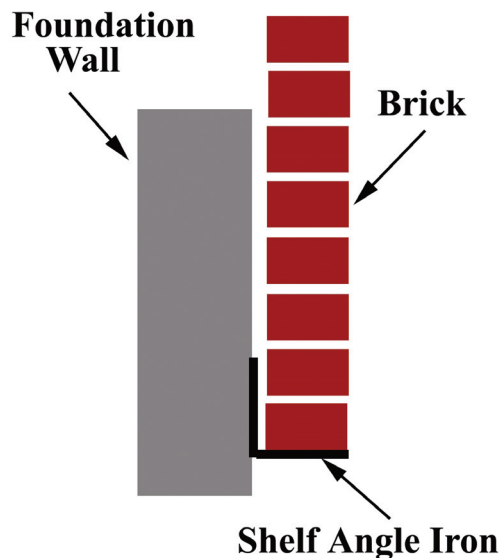
▲ Figure 2

Figure 2 reviews the concept of the shelf angle support typically used in the construction of residential brick walls. The angle iron is secured to the foundation wall to support the weight of the masonry veneer wall. This transfers the weight of the veneer wall to the foundation, which can support the load without significant deflection when the foundation is designed properly.

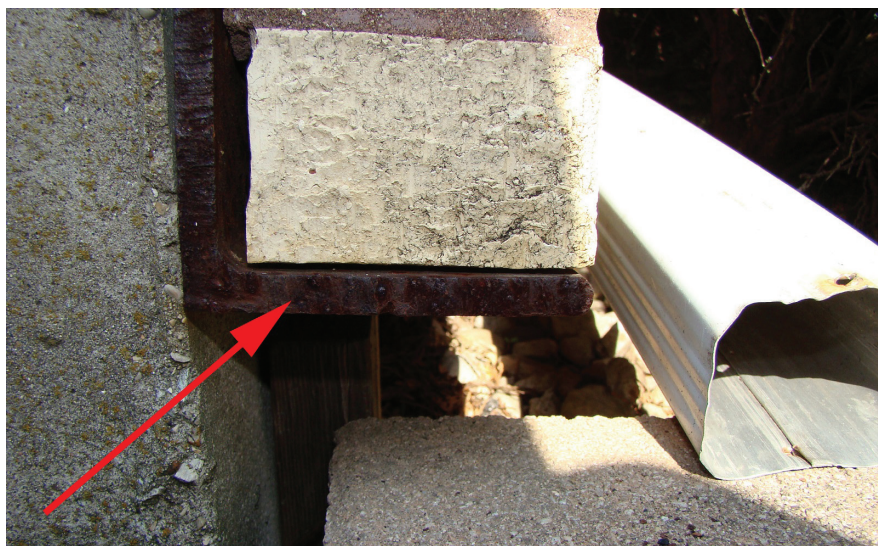
▲ Figure 3

Figure 3 is a view of the angle iron at one of the corners of the insured's ma-

sonry wall. The angle iron was fastened to the foundation wall at the ends only, with no fastening in the middle of the support.

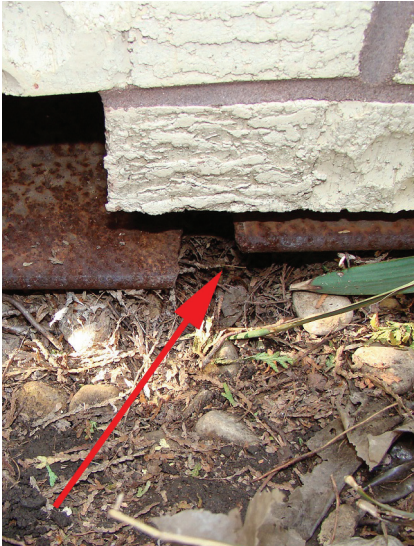
▲ Figure 4

Figure 4 shows the middle of the angle iron which has fractured and dropped down, causing a loss of support of the veneer and the initiation of a large crack in the grouting between masonry units.

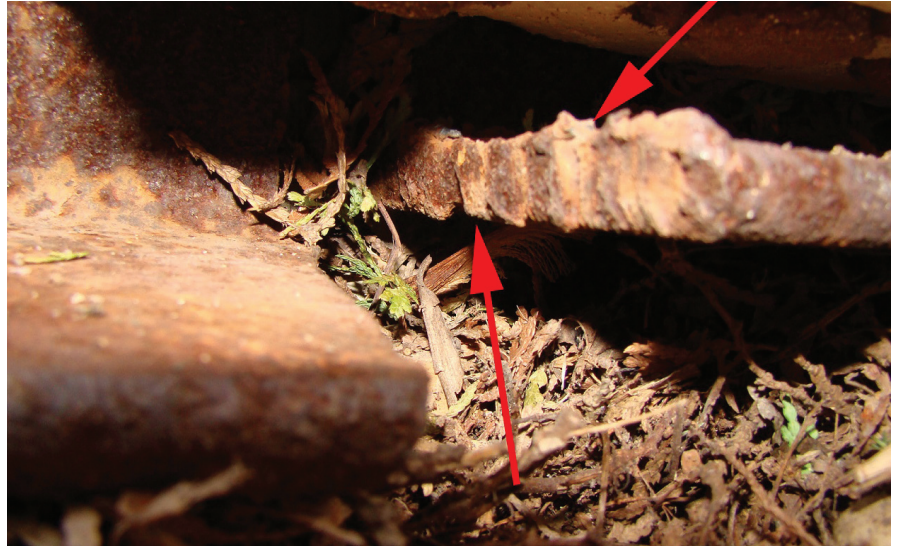
▲ Figure 5

Figure 5 is a close-up of the fracture surface. The lower arrow points to torch cut marks suggesting that this angle iron was cut at one time and then re-welded to form a straight piece. The upper arrow points to a poorly executed weld.

There was evidence of undercuts and lack of penetration, characteristic of a

poor welding technique that resulted in a defective weld. The weld eventually failed, causing loss of support and development of cracks in the veneer. The root cause is a construction defect resulting in

the failure of the shelf angle iron and not settling of the foundation. ❗
