## Motorcycle Wheel Valve Stem Failure

By Charles C. Roberts, Jr., Ph.D., P.E.

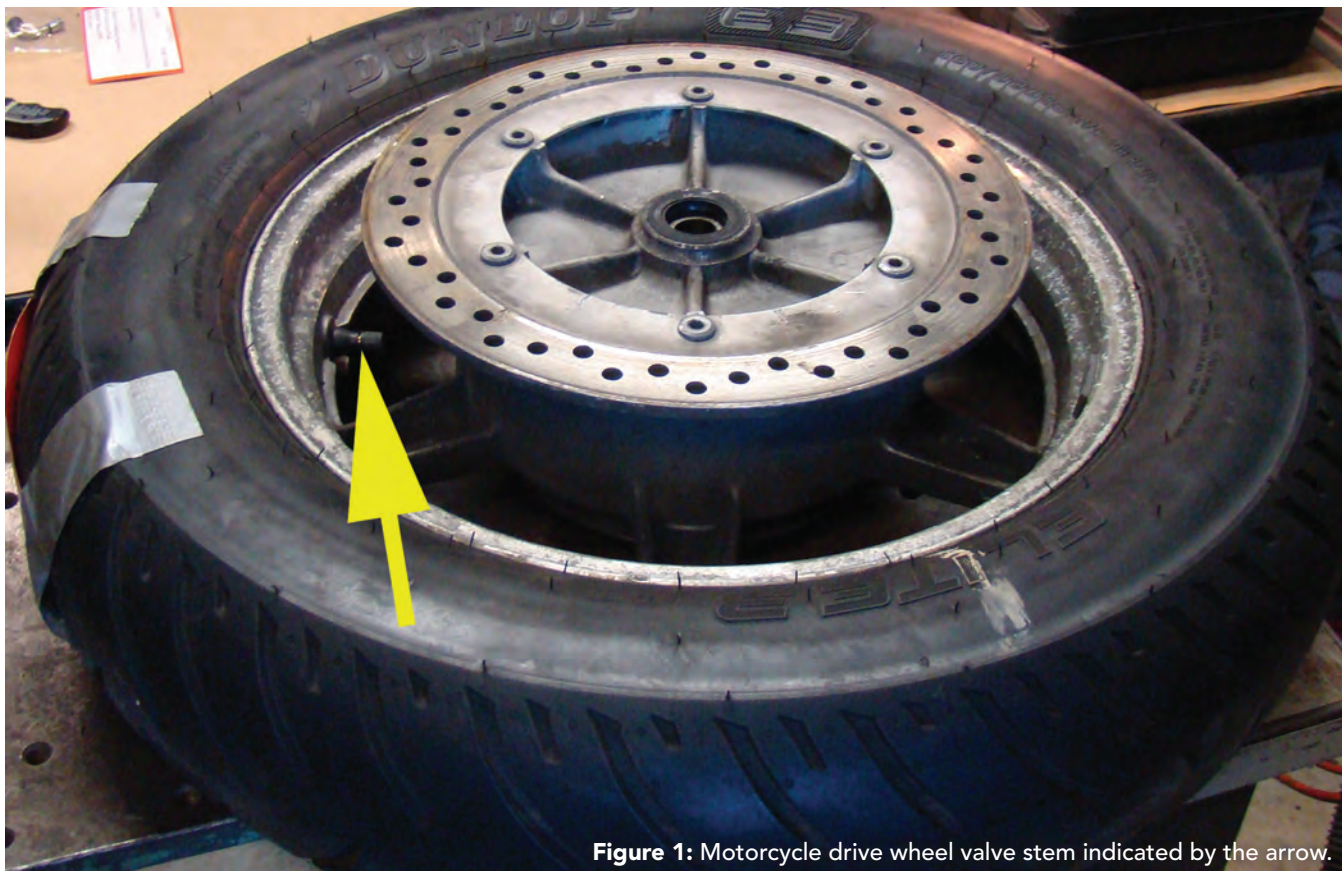
Figure 1: Motorcycle drive wheel valve stem indicated by the arrow.

**THIS CASE STUDY DEALS WITH AN** accident caused by a sudden motorcycle rear tire deflation. According to a witness, the motorcyclist riding ahead suddenly started to weave as a result of a flat rear tire. The motorcycle eventually traveled off the road and into a ditch, causing severe injury to the rider. The rear wheel of the motorcycle is depicted in Figure 1. The tire had been replaced approximately a month before the accident by a motorcycle shop and was a new tire. The tire bead was intact and appeared properly mounted. However, when pressurized, a severe leak was noted at the valve stem that is indicated by the arrow.

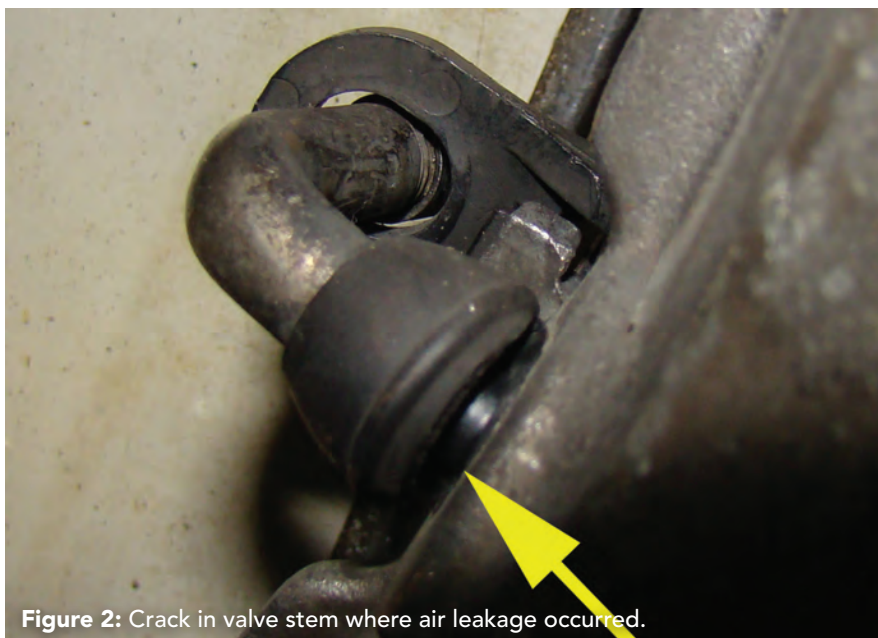
Figure 2 is a view of the valve stem with the arrow indicating the fractured rubber portion of the valve stem. Figure 3 shows the fracture surface of the valve stem

Figure 2: Crack in valve stem where air leakage occurred.

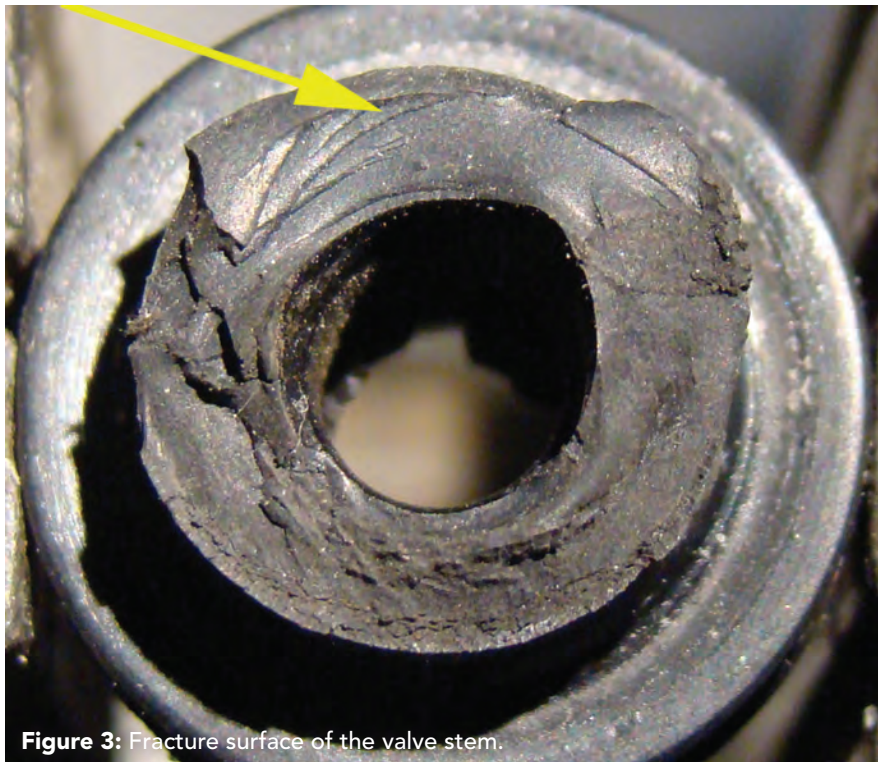
shaft. The arrow points to the striations indicative of crack growth over time.

This is a failure mode of rubber that appears over time as a result of the loss of elasticity from exposure to oxygen (ozone). The crosslinking of the polymer molecules by oxygen atoms over time causes a loss of flexibility of the rubber making it hard, brittle and prone to cracking. It is apparent that the valve stem was not replaced when the tire was replaced. It is common practice among motorcycle repair shops to replace the valve stem when the tire is changed. It was not done in this case, which resulted in an accident and injury to the motorcycle rider.

**Figure 3:** Fracture surface of the valve stem.
