Automobile Tie Rod Failure

By Charles C. Roberts, Jr., Ph.D., P.E.

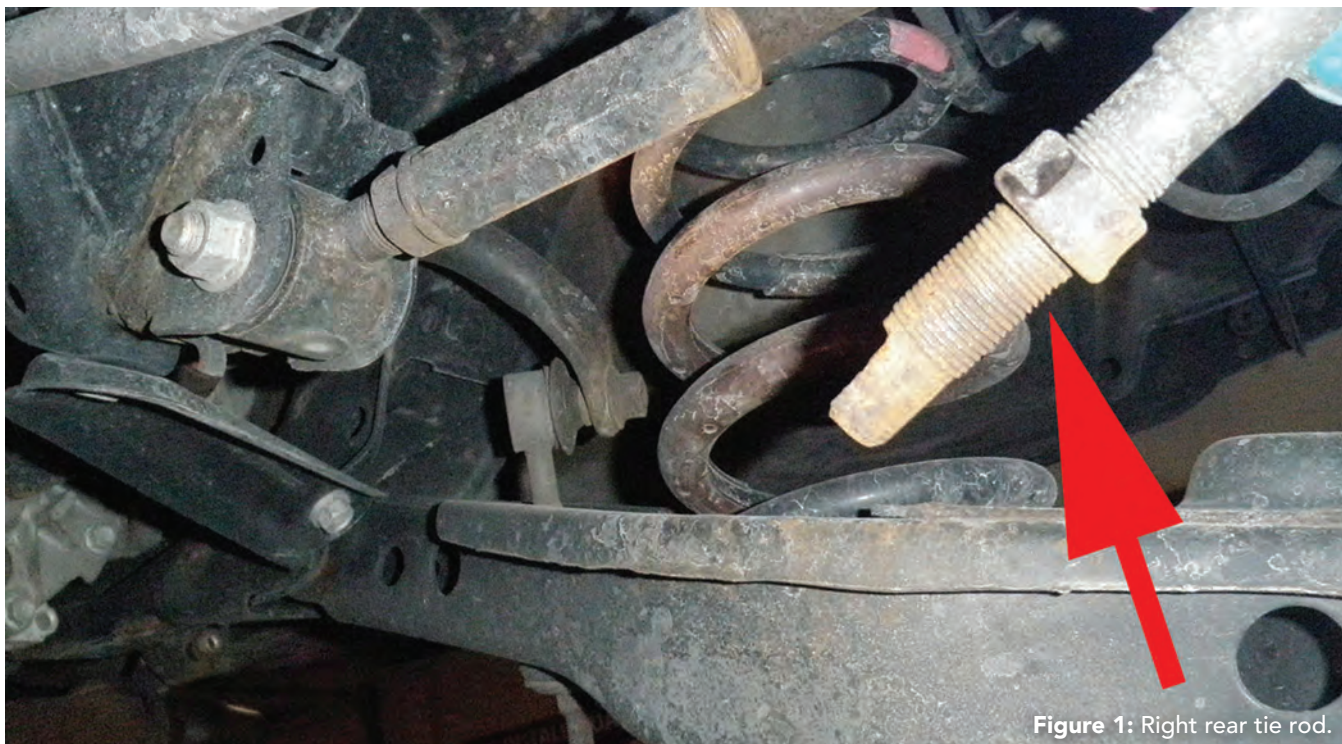
Figure 1: Right rear tie rod.

During an inspection in the body shop, there was severe damage to the front of the vehicle but no damage to the rear. It was discovered that the right rear tie rod that controls the alignment of the right rear wheel, as shown in Figure 1, had parted from its normal position (arrow). There was no evidence of an impact causing the tie rod, which controls the toe adjustment of the right rear wheel, to become detached. This can cause severe misalignment and loss of control that was consistent with that reported by the driver.

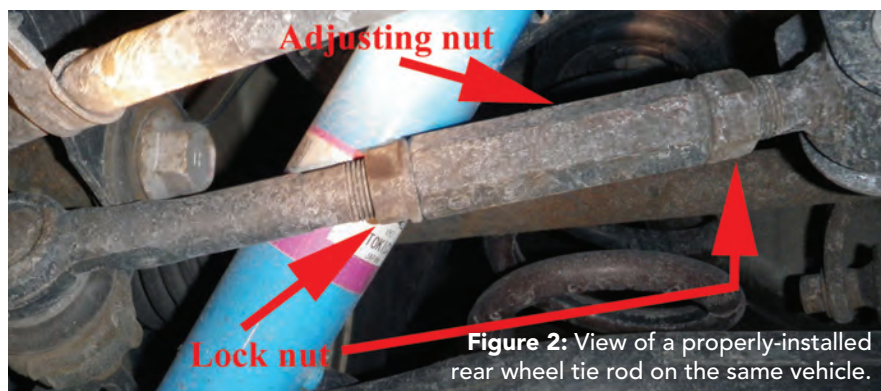
Figure 2: View of a properly-installed rear wheel tie rod on the same vehicle.

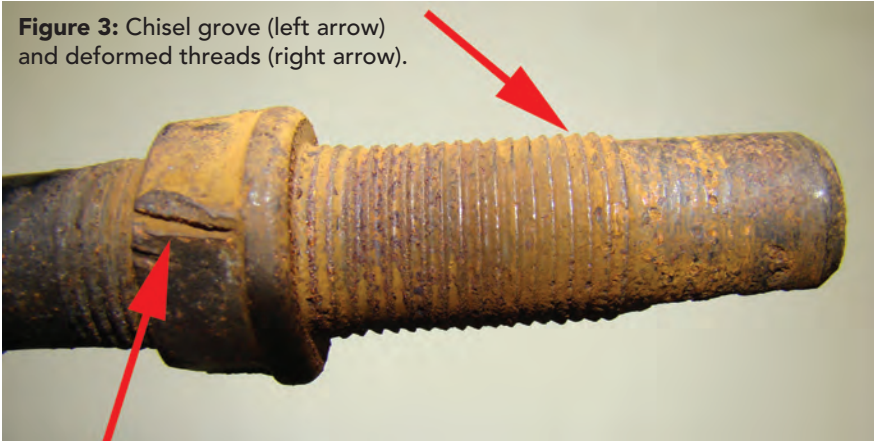
Figure 3 shows the threaded end of the tie rod that became detached. Close

inspection of the threads at the right shows that the crest of the threads is deformed to the right. This suggests that an excessive force was pushing the adjusting nut to the right. The lock nut shows a chisel groove, suggesting that an individual was attempting to loosen the lock nut by turning the nut counter-clockwise. This particular nut and screw has a left-hand thread,

which means turning counter-clockwise tightens the lock nut against the adjusting nut.

Figure 3: Chisel groove (left arrow) and deformed threads (right arrow).

Apparently, excessive torque was applied to the lock nut which damaged the threads under the adjusting nut. As a result of normal tie rod loading from drive wheel traction and road variations, the tie rod eventually parted from the threaded connection, causing severe right wheel misalignment and loss of vehicle control.

The root cause is excessive torque applied to the lock nut which damaged the adjusting nut area threads. This is an improper adjustment procedure. The vehicle suspension had recently been realigned at a local shop.

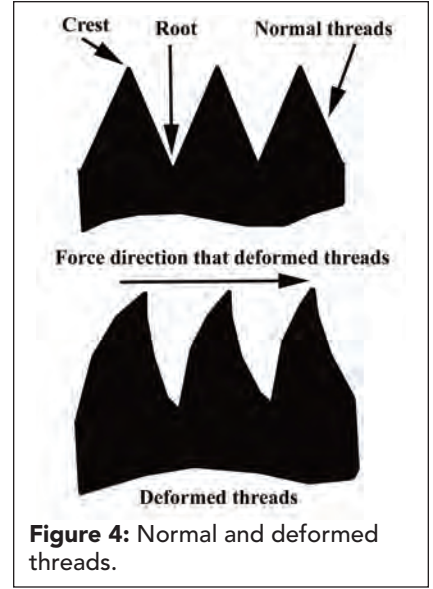
Figure 4 is a drawing of the nature of the damage to the threads. The upper drawing shows the crest and the root of a normal threaded screw. The lower drawing shows the damaged threads with the crest deformed to the right, which is consistent with a force to the right.

Figure 4: Normal and deformed threads.
