Small Worm-Style Hose Clamp Failures in Automotive Applications

Charles C. Roberts, Jr. PH.D., P.E.,
C. Roberts Consulting Engineers, Inc.
2090 Brush Grove Road
Rochelle, IL 61068 USA
www.croberts.com

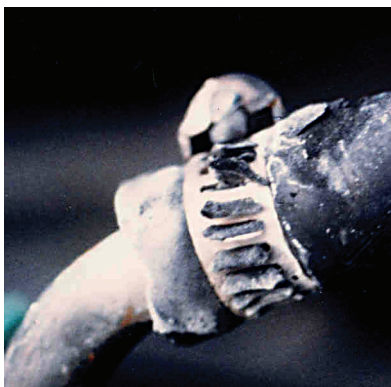
This is usually done by feel, but if the hose material starts to extrude through the grooves in the hose clamp, this is probably too much torque, as illustrated in **Figure 2**. Apparently in this case, a leaking fuel hose was over tightened, which stopped the leak temporarily. The leak redeveloped later on, causing a fire that destroyed the vehicle.

Fig. 2 — Over-torquing can cause the hose material to extrude through the grooves in the hose clamp.

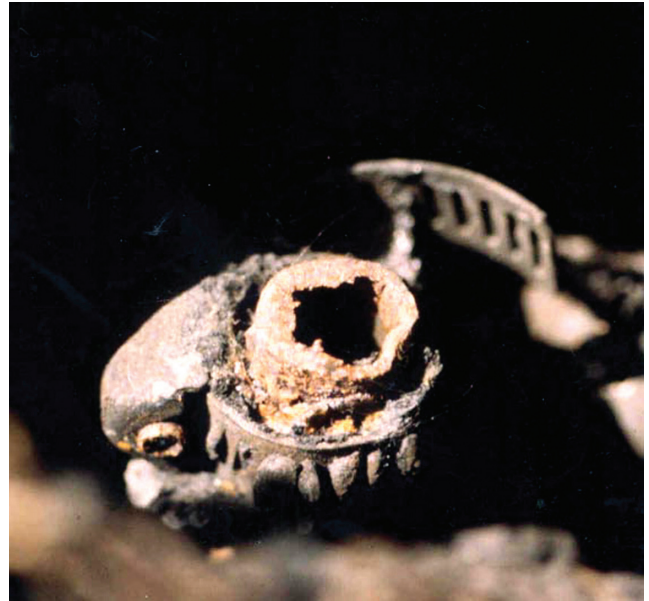
Figure 3 shows a slightly different cause of a fuel leak, which occurred at a hose clamp, and which also resulted in the loss of the vehicle. Apparently, there had been a leak in the metal fuel tube and the leaking area of the tube was removed with a saw. This resulted in an irregular surface as

Fig. 3 — Irregular surface resulting from where a leaking area in a metal fuel tube was removed with a saw.

A rubber hose along with a small worm-style hose clamp were substituted. Additionally, it should be noted here that polymer hoses can only accommodate a certain amount of distortion of a round tube and may leak eventually, driven by environmental conditions such as vibration and high temperature. Because of the distorted shape of the metal fuel tube, the hose clamp became over-tightened in an attempt to eliminate leakage, as can be seen by the extruded polymer through the gear grooves.

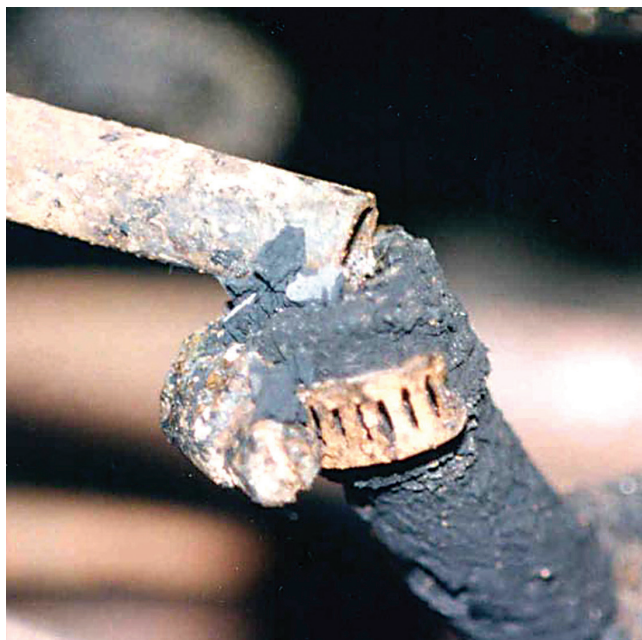
In yet another case, as shown in **Figure 4**, the fuel hose slipped off the metal fuel tube, resulting in a fuel related fire in the vehicle.

This situation resulted from insufficient clamp torque and the positioning of the worm-style clamp. It appears that the clamp may have only partially engaged the fuel tube, significantly reducing the clamping force.

Fig. 4 — Fuel hose slipped off the metal fuel tube, resulting in a fuel related fire.

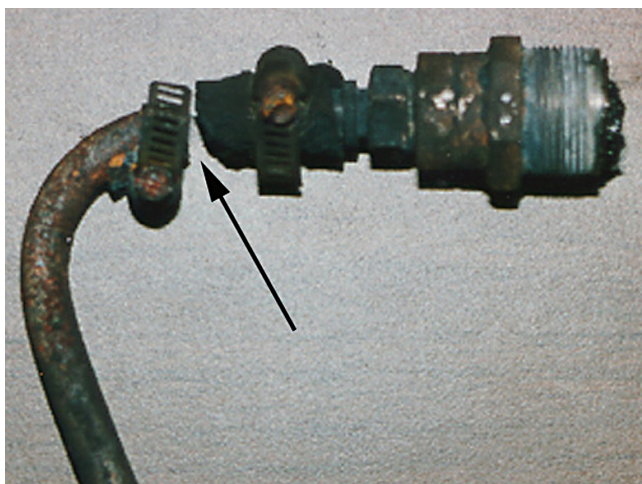
Figure 5 illustrates another case of a polymer hose, which has been substituted for a part of a metal fuel tube. This leakage is most likely a result of the polymer not being able to handle the high temperatures in the engine compartment. The fuel tube should have been replaced and not repaired with a polymer hose and a worm-style hose clamp. This is a misapplication.

Fig. 5 — Polymer substituted for part of a metal fuel tube not able to handle high temperatures in the engine compartment.

Corrosion can be a problem with low-quality clamp material, which can also cause future failure. It is advisable to select clamps constructed of high quality material, regularly inspect for leakage and follow the manufacturer's recommendation for tightening torques.
