Boating and Water-Skiing Accidents*

Charles C. Roberts, Jr., Ph.D., P.E.

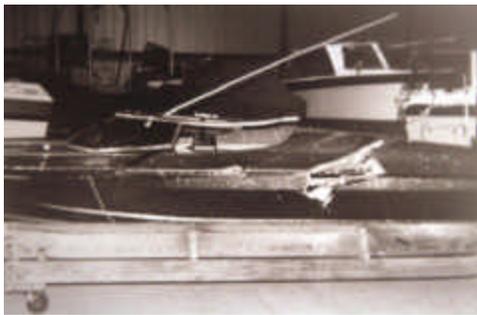
Figure 1 is a photograph of an outboard motorboat that was struck broadside by another boat. Photographs of side and front views of each hull plus close-up photographs of damage patterns are desirable. Look for missing parts such as cleats, anchors and other heavy objects. It is possible that these items may be at the bottom of the waterway where the accident occurred. Visiting and photographing the scene is very helpful. It may be pos-

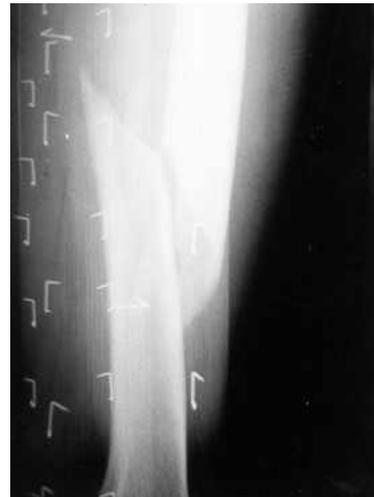
The shape of the waterway may have contributed to the accident such as a sharp bend or an obstruction such as a bridge. Check to see if appropriate navigation warnings or directives are visible at the accident scene. A no wake sign at the accident scene may have been ignored by a speeding boat operator. Witness statements can be helpful in reconstructing the events leading up to the accident. Obtaining a geological survey map can lend accuracy to the locating of various artifacts involved in the accident. For single boat accidents, where a member of a party associated with one boat, such as a water-skiier is injured, an immediate inspection of the equipment involved is essential. Figure 2 is a radiograph (X-ray) of the fractured femur of a lady water-skiier. Figure 3 shows

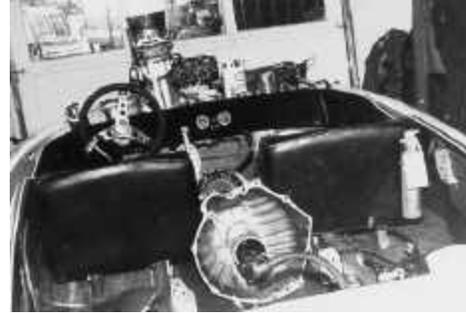
For boating accidents resulting in property damage only, an immediate inspection is also necessary. Figure 4 is a view of an in-board motorboat that traveled through a large wake, resulting in water ingestion into the engine. Cracks were found in the engine block and were claimed to be caused by hydrostatic lock-up from the water ingestion. Metallurgical analysis of the cracks indicated a fatigue failure associated with long term engine operation and not the single event of water ingestion. If the engine block

had not been recovered and preserved, the fatigue failure would not have been identified. Immediate action in investigating boating or water-skiing accidents can save valuable evidence that may otherwise be lost. During rescue operations, water-skis, tow ropes and other equipment can float away, never to be recovered. The importance of preservation of equipment involved cannot be over estimated.
