By Charles C. Roberts

## Crane Accident Reconstruction

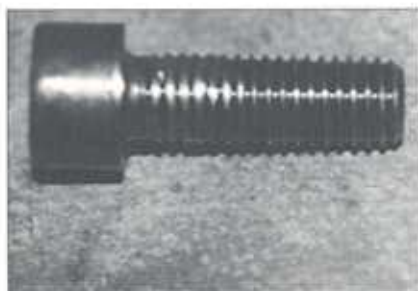
Figure 8 is a view of a transmission used to hoist the load on a crane via a wire rope and drum. Figure 9 is a view of a bolt that backed out of position causing the transmission to release and the load to drop. The load was within the design envelope of the crane. This condition is a deficiency attributed to assembly of the transmission. The bolt was not coated with a frictional com-

pound to retain it in the proper position.
