By Charles C. Roberts

# Crane Accident Reconstruction

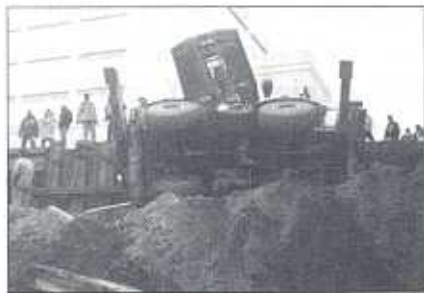
Figure 1 shows a mobile crane that

tipped over when the load was swung perpendicular to the long axis of the mobile unit. The load was small, the boom was fully extended but the outriggers were not fully extended. According to the crane operator the vehicle slowly tipped over.

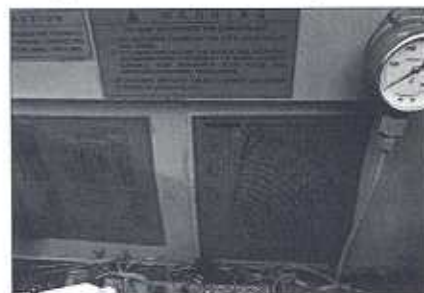
Figure 2 is a view of a typical load-

ing/stability chart required in most cranes. According to the chart, the crane operator had moved the crane outside its stability envelope causing the tipping accident, a common accident.

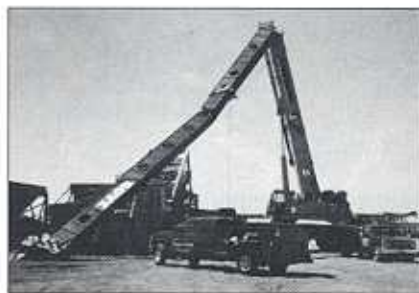
Figure 3 shows another common ac-

cident with telescoping cranes. According to the operator, he was booming to the right, towing a load from right to left. This causes side loading to the crane boom. Although the crane was being operated within limits for vertical loading, it was not within limits for side loading. In this case, the crane was overloaded, resulting in a buckling failure. It should be noted that many box section telescoping cranes such as this cannot tolerate much side loading, as

is typically mentioned in manufacturer's literature.

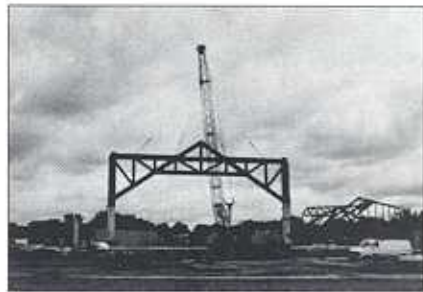
Figure 4 is a view of a crane lifting a truss system into position. As the truss was placed on the concrete piers, workers tightened bolts to secure the structure. During the lift, one of the sling cables snapped causing severe dynamic

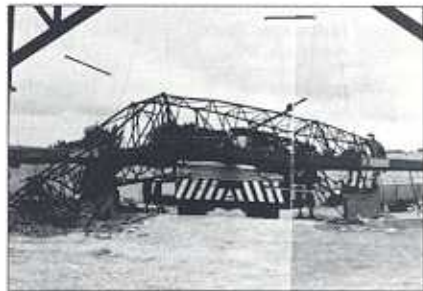
Figure 5

forces to be applied to the crane which collapsed as shown in Figure 5. In this particular case, the crane operator was trying to keep the truss in position while it was secured. Without a load indicator, the crane operator was relying on visual deflection and intuitive feel to prevent overloading. Since the struc-

ture offered little deflection during the lift, overloading of the sling occurred, resulting in the accident. Many overloading conditions occur when a crane attempts to pick a load that is secured to some heavy or immobile object.

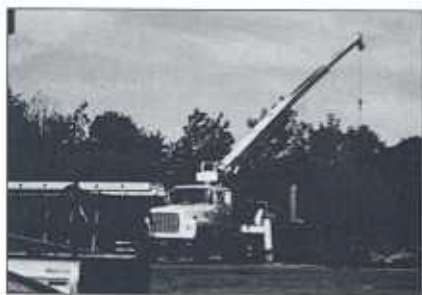
Figure 6 is a view of a telescoping boom crane that failed while loading material whose weight was well within the crane parameters. Disassembly of the hydraulic cylinders revealed a condition where the nut securing the hydraulic piston backed out causing loss

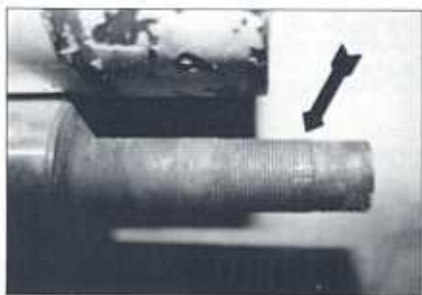
of hydraulic cylinder support (Figure 7). The damaged threads of Figure 7 indicate that the nut loosened and detached when about 4 threads were engaged. It appeared that the nut was improperly torqued.

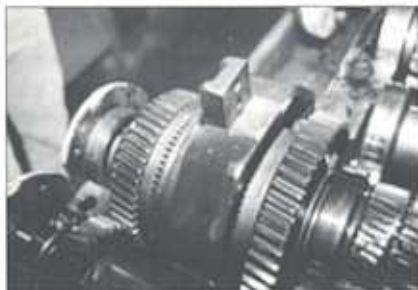
Figure 8 is a view of a transmission used to hoist the load on a crane via a wire rope and drum. Figure 9 is a view of a bolt that backed out of position causing the transmission to release and the load to drop. The load was within the design envelope of the crane. This condition is a deficiency attributed to assembly of the transmission. The bolt was not coated with a frictional com-

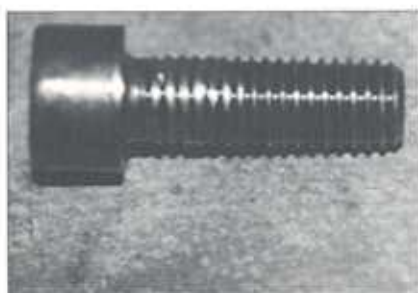
Figure 9

pound to retain it in the proper position.
