Furnace and Water Heater Related Fires*

Charles C. Roberts, Jr., Ph.D., P.E.

*Reprinted from "Claims Magazine"

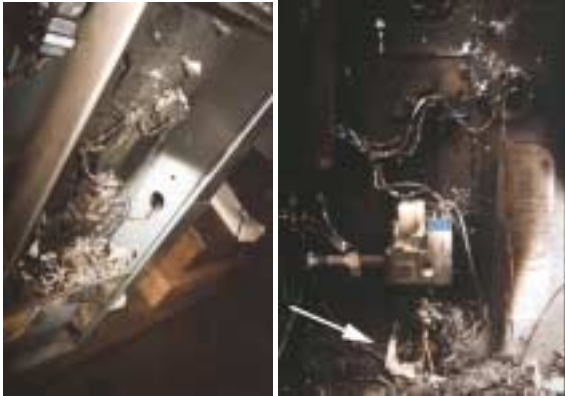
Figure 1

furnace that sustained a relatively minor fire that initiated in the vicinity of the high voltage module that drives the spark ignition system. The arrow in Figure 2 points to the badly damaged module which was the ignition source of the fire. Although the direct damage to the home from the fire was minimal, the induced damage was substantial. The home was unoccupied while the insured was on vacation during the winter. The furnace caught fire but fortuitously self extinguished from lack of fuel in the vicinity of the fire origin. This caused the furnace to be inoperative, resulting in severe water damage to the home once the frozen water pipes thawed. The exact cause of the failure of the ignition module could not be determined because of severe damage to the unit from the fire.

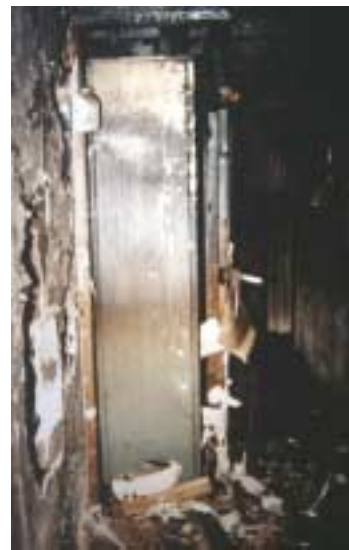
Figure 3 is a view of an old forced air furnace in a home that was badly damaged by a fire. Figure 4 is a view of a typical floor heating duct register that is badly burned. Figure 5 is a

view of another register that is connected to the forced air system and is in good condition. Did the furnace overheat and cause a fire? The controls and burner which were located at the lower portion of the furnace were in good condition. Testing showed no malfunction in the burner gas valve or limit switches. The most severely burned areas were near a few registers on the forced air ducting that was far away from the furnace. If the furnace was the heat source causing severe pyrolysis at the registers, how come the wood near the burners or the wood near some other registers is not pyrolyzed. This is a violation of the principles of heat transfer since heat does not naturally flow from a cold source to a hot source. Chemical analysis in

the vicinity of the badly burned registers confirmed the existence of an accelerant.

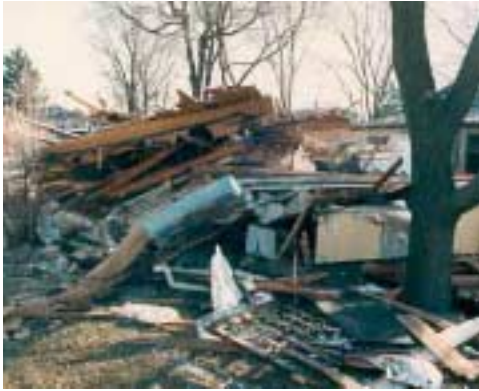
Figure 6 is a view of a home after a natural gas explosion had occurred. A fire resulted but was quickly extinguished by the fire department. The furnace and water heater were

suspected as having malfunctioned but no apparent deficiencies were found. Within a week, two more homes on the same block suffered explosions. Suddenly the focus of the investigation was directed toward the gas utility piping. The gas main was excavated and several cracks were found in the piping like that shown in Figure 7. Figure 8 is a view of a typical part of the gas main showing markings indicative of having been struck by an excavator. About 10 to 15 years before the loss, water pipes had been placed in the ground next to the gas main. Apparently the excavator had struck the gas piping during installation causing random cracks throughout the piping system. Seasonal soil movements enlarged the cracks which began to leak natural gas more profusely. Some of the residents noticed brown areas on their lawns despite every ef-

fort to properly care for the lawn during the summer. This resulted from natural gas filtering through the soil to the atmosphere. However, when the winter frost layer developed, the avenue of escape for the natural gas was blocked. The natural gas then moved horizontally, entering voids near sewer lines and other utilities, causing gas accumulation in some homes. The gas was most likely ignited by pilot systems of gas fired equipment.
