Claims[®]

Shedding Some Light on Auto Accidents

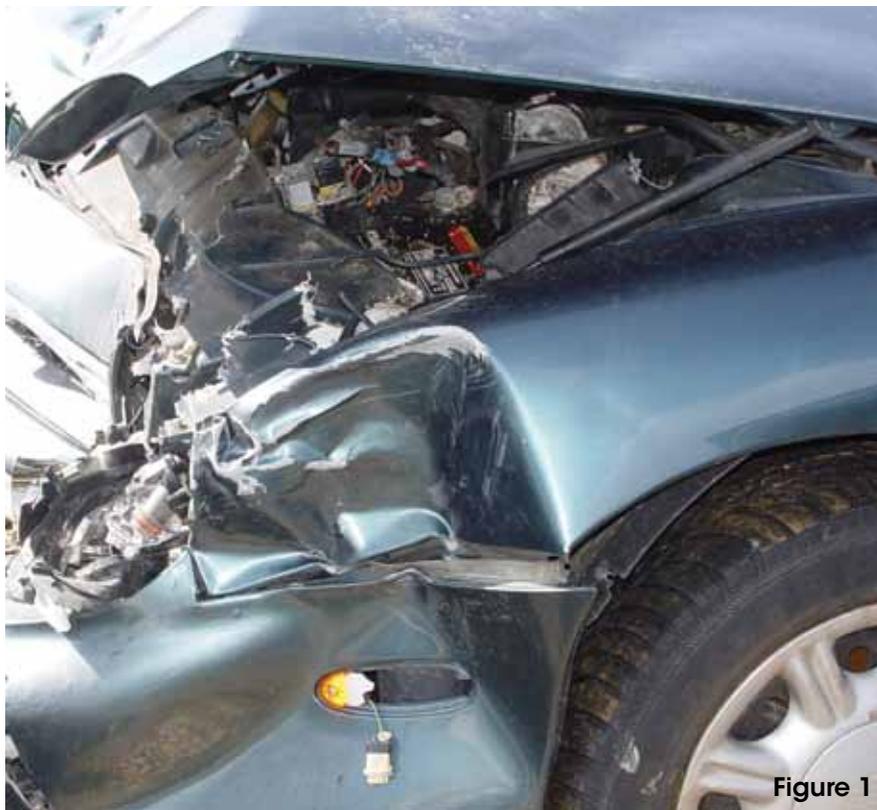
The damaged vehicle in Figure 1 has automobile lamps still in the vehicle, allowing physical evidence as to whether the lights were on or off to be identified. This article reviews several case studies of automobile lights and what information can be deduced regarding whether the lights were on or off.

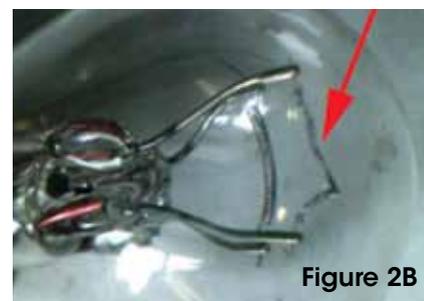
In Figure 2A, the bulb is a standard sealed beam 1157 bulb found in many tail light assemblies. Figure 2B is a bulb extracted from the rear impact area of a vehicle. The bulb was not fractured, but the filament, as indicated by the arrow, is severely deformed.

When the light is incandescent (on), the filament is very hot and ductile, which means it deforms easily. The forces of the impact cause the deformation. If the light had been off, no deformation would be noted since the cold filament is much more rigid.

The deformed filament in Figure 2B suggests that the light was incandescent at the time of impact. Likewise, the halogen lamp on the right in Figure 3 is deformed when compared to a new lamp shown on the left, suggesting it was incandescent at the time of the accident.

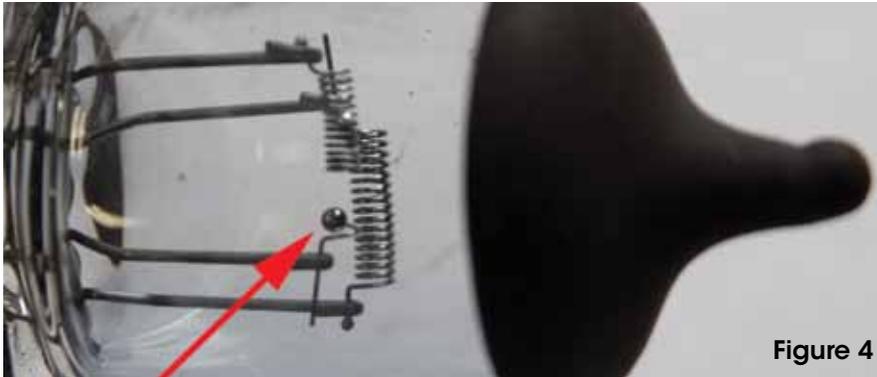
that were incandescent at the time of the accident is the formation of a small ball of tungsten, as shown by the arrow in Figure 4. During impact, a filament may break, and as this occurs, it generates an electric arc, causing a high temperature and the formation of a melted ball of tungsten. The filament in Figure 4 was incandescent at the time of the accident.

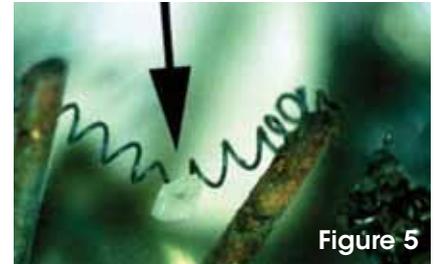
Figure 5

In Figure 5, the bulb has fractured and a small shard of glass is found melted

into a filament. This indicates that the filament was incandescent at the time of the fracture.

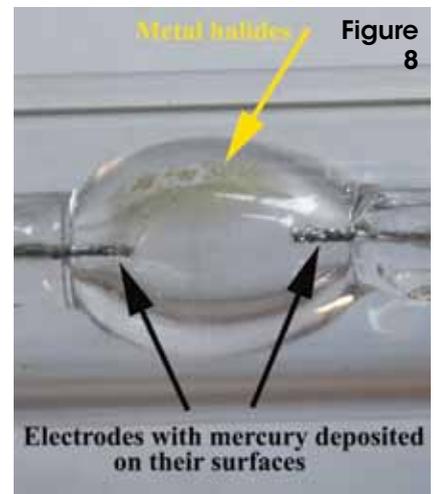
Figure 8 is a close-up of the arc tube on a new lamp. The metal halide salts have a yellowish color as indicated by the yellow arrow above the arc tube. While in operation, the metal halide salts are vaporized and distributed throughout the arc tube. If the arc tube is fractured from the accident, then these gaseous components escape. Upon cooling, there is very little evidence of deposits on the inside of the fractured arc tube, which suggests the light was on at the time of impact.

Oxidized electrodes (greyish blue in color) and/or ductile deformations are also an indicator that the light was on at the time of impact. Figure 8 also shows mer-

cury deposits on the electrodes of a new lamp. If the lamp is powered at the time the arc tube is fractured, mercury escapes and there is little left on the electrodes.
