# Claims<sup>®</sup>

May  
2018

# Shedding Some Light on Auto Accidents

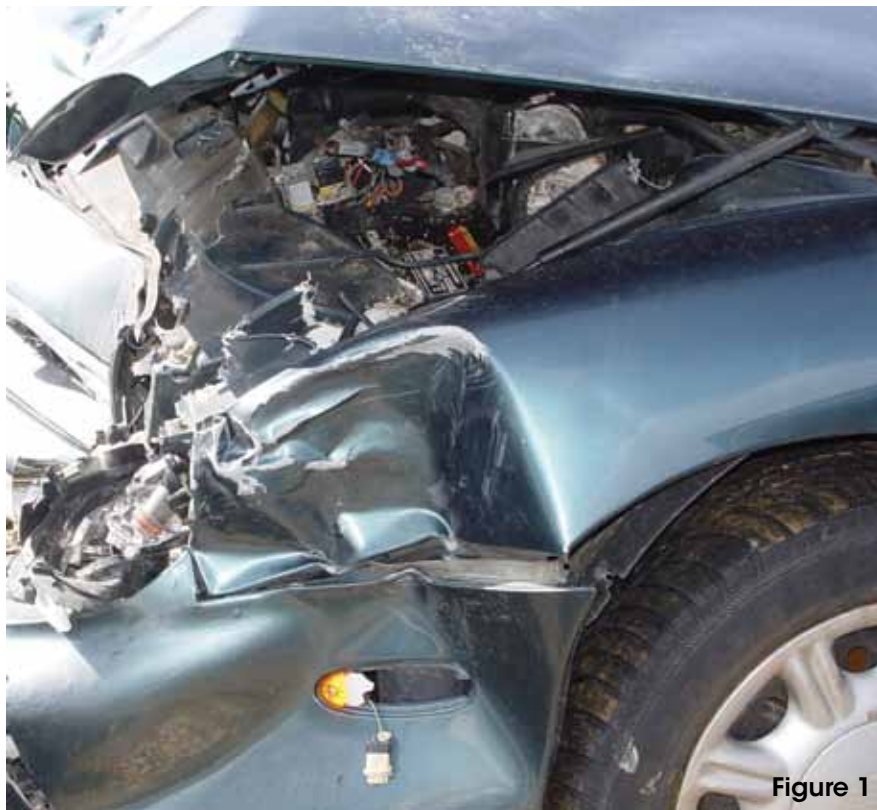
The damaged vehicle in Figure 1 has automobile lamps still in the vehicle, allowing physical evidence as to whether the lights were on or off to be identified. This article reviews several case studies of automobile lights and what information can be deduced regarding whether the lights were on or off.

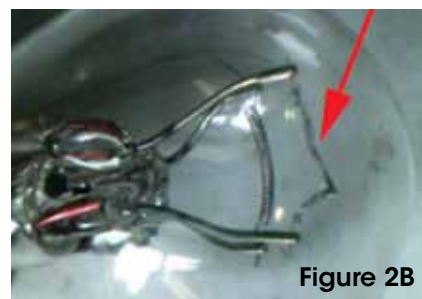
In Figure 2A, the bulb is a standard sealed beam 1157 bulb found in many tail light assemblies. Figure 2B is a bulb extracted from the rear impact area of a vehicle. The bulb was not fractured, but the filament, as indicated by the arrow, is severely deformed.

When the light is incandescent (on), the filament is very hot and ductile, which means it deforms easily. The forces of the impact cause the deformation. If the light had been off, no deformation would be noted since the cold filament is much more rigid.

The deformed filament in Figure 2B suggests that the light was incandescent at the time of impact. Likewise, the halogen lamp on the right in Figure 3 is deformed when compared to a new lamp shown on the left, suggesting it was incandescent at the time of the accident.

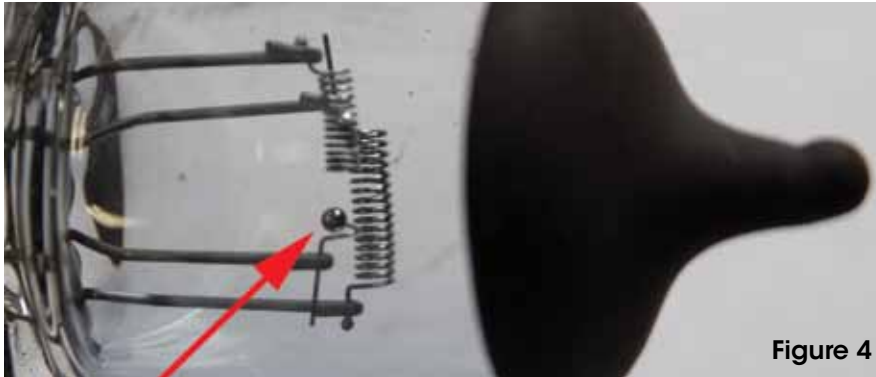
that were incandescent at the time of the accident is the formation of a small ball of tungsten, as shown by the arrow in Figure 4. During impact, a filament may break, and as this occurs, it generates an electric arc, causing a high temperature and the formation of a melted ball of tungsten. The filament in Figure 4 was incandescent at the time of the accident.

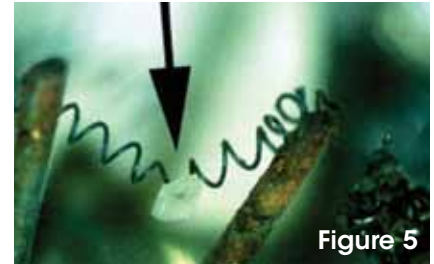
Figure 5

In Figure 5, the bulb has fractured and a small shard of glass is found melted

into a filament. This indicates that the filament was incandescent at the time of the fracture.
