Claims[®]

March
2019

Automotive Cartridge Oil Filter Fires

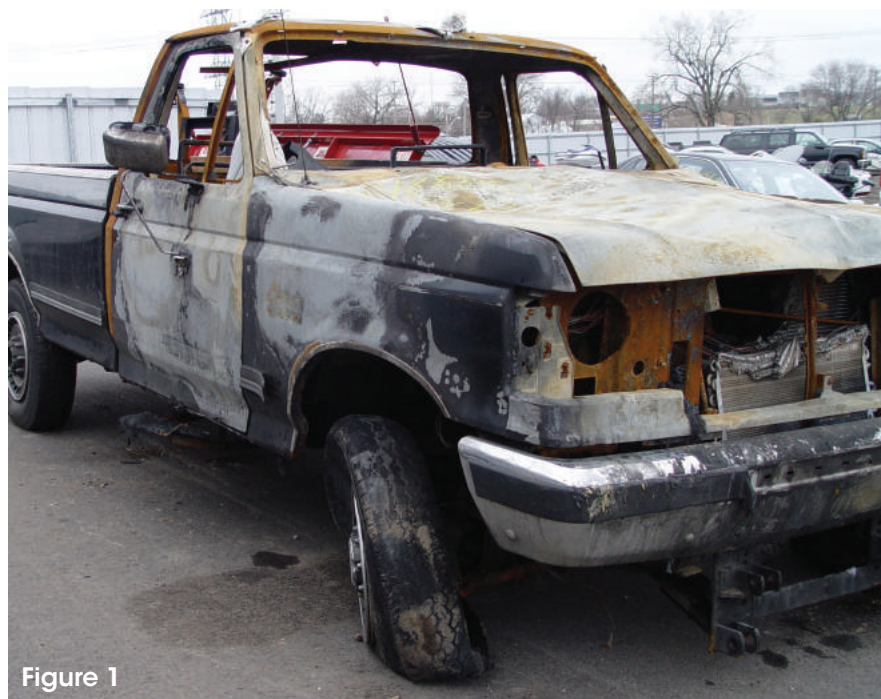
Upon examination of the vehicle, the origin of the fire is in the vicinity of the oil filter. Figure 1 is an example of such a vehicle that sustained a fire as a result of an improperly installed oil filter.

What happened is that oil leakage occurs from the improperly installed cartridge oil filter. The oil sprays or migrates to a hot vehicle component, such as an exhaust manifold or turbocharger

housing. The oil is ignited, resulting in the total loss. Usually when the oil filter is changed, the technician uses a wrench to unscrew the cartridge oil filter. The technician then checks the oil filter housing to make sure the oil seal from the removed

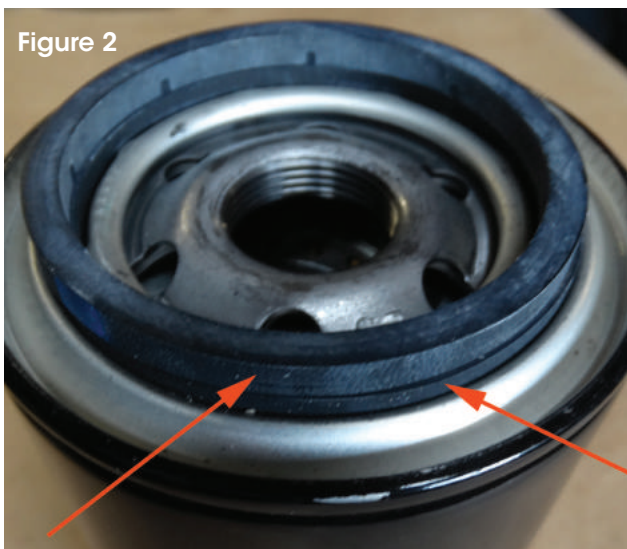
on the housing and the previous seal remains, then two seals will be in place when the replacement filter is installed. This will usually result in oil leakage since the set up will not be able to sustain the engine oil pressure.

Figure 2 shows the filter with two seals in place. The left arrow points to the old seal and the right arrow points to the new seal. The two seals on top of one another usually do not resist the

oil pressure from the engine, resulting in leakage.

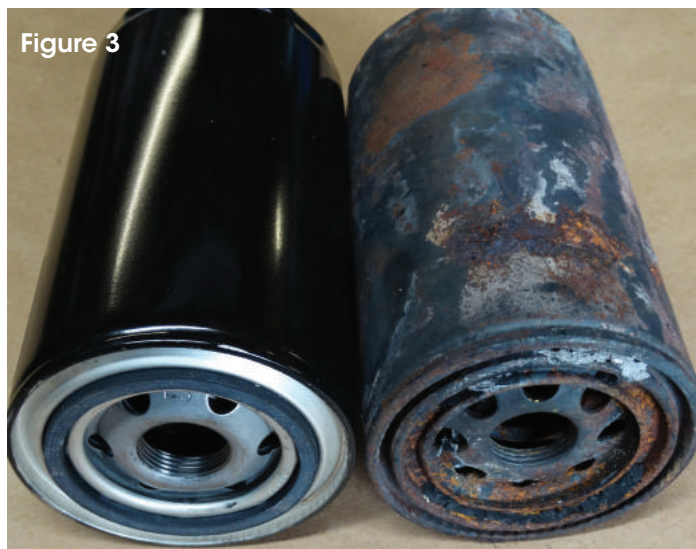
A second problem with oil filter installation is improper threading of the oil filter onto the housing. Figure 3 shows an oil filter to the right that was cross-threaded during installation.

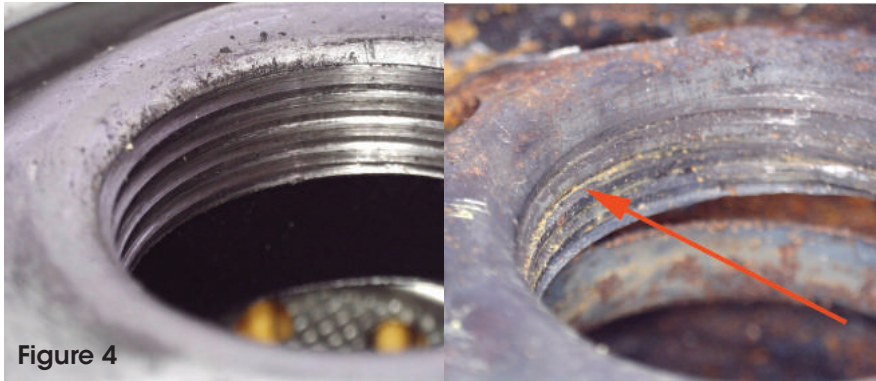
proper threading. In this case, the location of the oil filter housing in the vehicle was hard to reach. It is difficult to determine if the filter is threaded properly in tight locations. Consequently, when the installing torque of the filter increases, a technician may think that the filter is being seated properly when in fact the increased torque experienced is a result of cross-threading. Depending on the amount of oil seal compression, the seal may leak almost immediately or take some time to fail and leak.

Figure 4 is a close-up of the threads on the oil filter to the right as compared to a new oil filter. In Figure 4 the worn threads on the right (arrow) are a result of im-
