Water Pipe Failure Analysis

Charles C. Roberts, Jr. Ph.D., PE

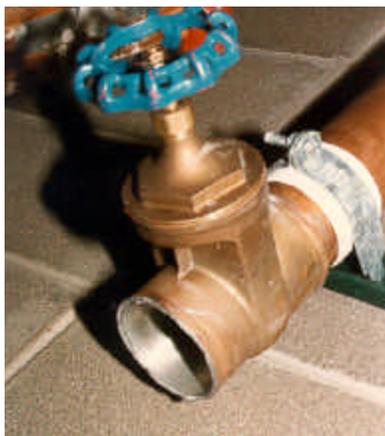
Figure 1 is a view of a failed solder joint on a 3 inch pipe. The water drained into the basement of a large office complex causing

significant damage to a telephone switching system and computer complex. The failed joint was a result of insufficient heat during the solder process causing poor solder penetration and a weak joint. Figure 2 shows a similar cold solder joint that caused a substantial water loss in an apartment complex.

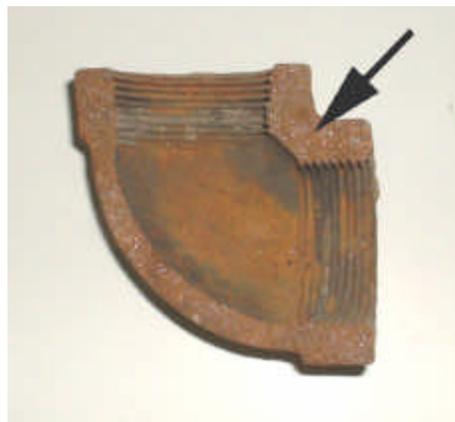
Figure 3 is a view of an elbow taken from a 4 inch line. The pipe suddenly fractured causing water to drain downward through several floors in an office building. Microscopic analysis revealed a casting defect as shown by the arrow. This tended to raise the stress in the pipe wall resulting in final failure. The fracture surfaces were well preserved by field personnel facilitating the analysis.

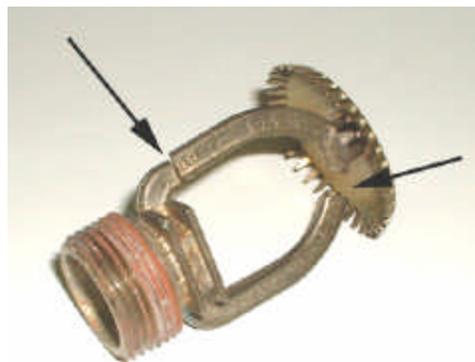
Figure 4 shows a typical sprinkler head that was found to have an unusually high

failure rate. Several heads had activated for no apparent reason watering down offices and industrial facilities. In Figure 4, the arrows point to cracks in the bronze support frame. This was probably a result of shrinkage during the casting operation, a manufacturing defect.

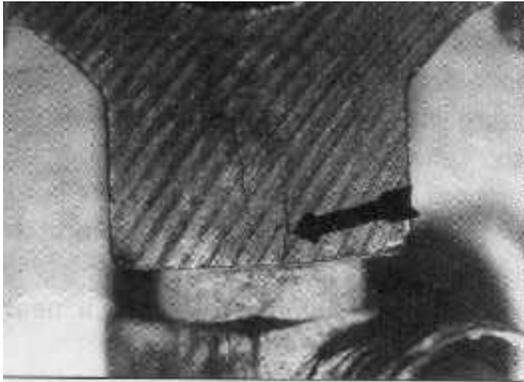
Figure 5 shows over stress related cracks as a result of excessive tightening of a pipe fitting. This eventually resulted in leakage and significant property loss to a residential building.

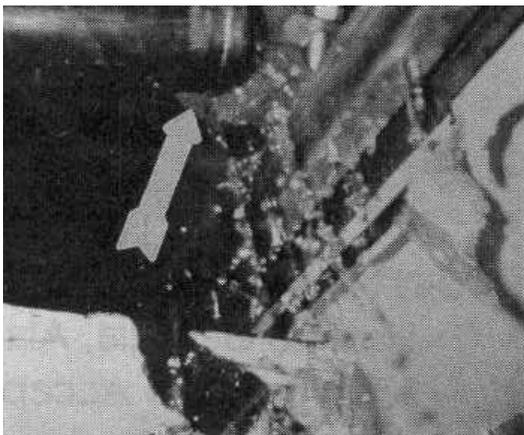
Figure 6 shows a leaking grooved coupling that failed due to severe strain on a pipe from poor installation. This was a 5 inch water line that flooded an office building basement nearly drowning the janitorial staff.

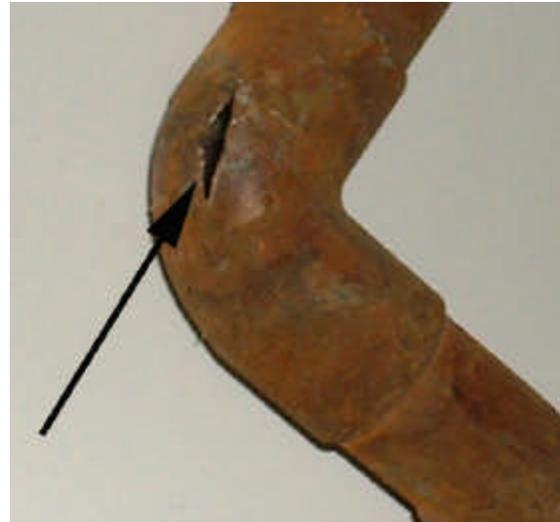
Figure 7 shows the classic "fish mouth" fracture associated with excessive localized hoop stress consistent with freezing in the water pipe.

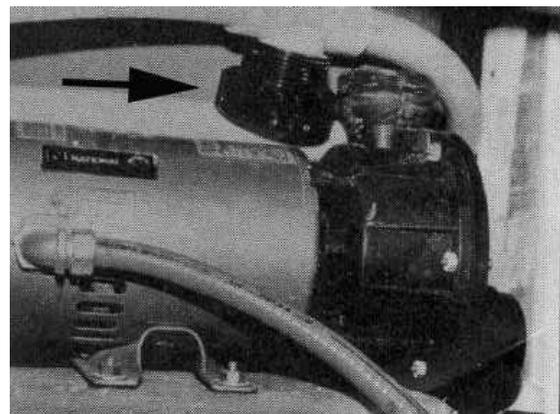
Figure 8 shows fittings that vibrated loose on a water pump motor causing substantial water damage to a residential building. The pump couplings were not secured properly to withstand the pump vibration.
