## Water Pipe Failure Analysis, Part II

Charles C. Roberts, Jr. Ph.D., PE

Accidents caused by failed piping are often catastrophic in that the water damages expensive computer equipment, elevator electronics, interior decorating, etc. This article presents additional case studies that may help decipher the cause of a particular failure.

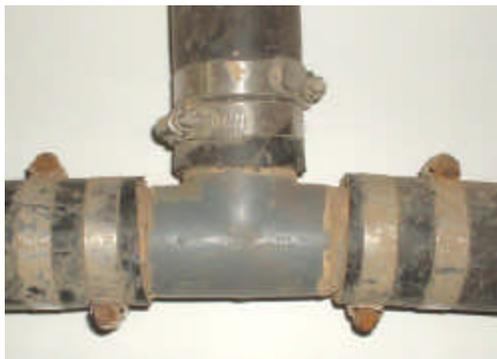
Figure 1 is a view of a polyvinyl chloride (PVC) pipe Tee joining three hoses. Figure 2 is a view of typical cracks found in the pipe about a year after it

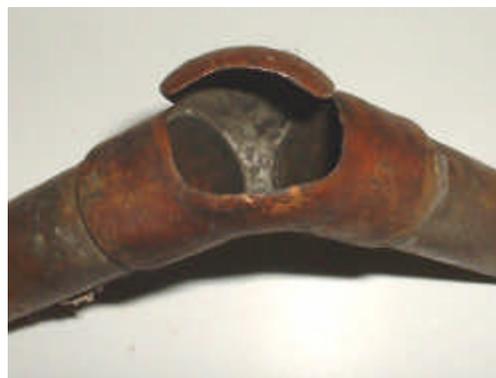
Figures 3 and 4 on the previous page show additional examples of freeze related failures. The large deformations of the copper elbow in Figure 3 and the large deformation of the cast iron T of Figure 4 are characteristic of freeze related damage. During freezing, the cracking of the fittings does not necessarily relieve internal pipe pressure and the freeze slug continues to deform the metal until it thaws or until all freezing related expansion has ceased.

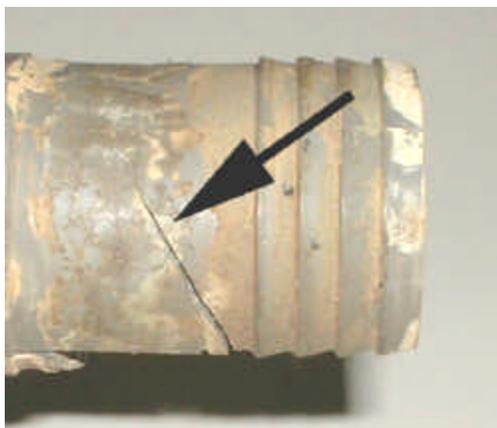
Figure 2

was buried in the ground as part of a swimming pool installation. The cracks continued to grow, causing water leakage that resulted in a significant repair job to the pool installation. The cause of the fracture in the PVC pipe apparently was the usage of a solvent based pipe sealing compound that chemically attacked the PVC and weakened its structure. As polymer (plastic) piping parts become more common, chemical attack failure modes of this nature will be more prevalent.

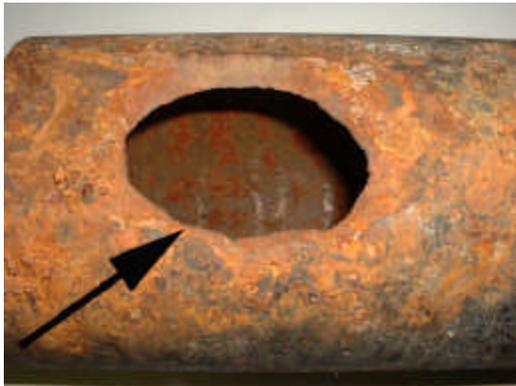
Figure 5 is a view of a galvanic corrosion related failure in the vicinity of acidic soil. Such failures occur several years after installation. Figure 6 is a

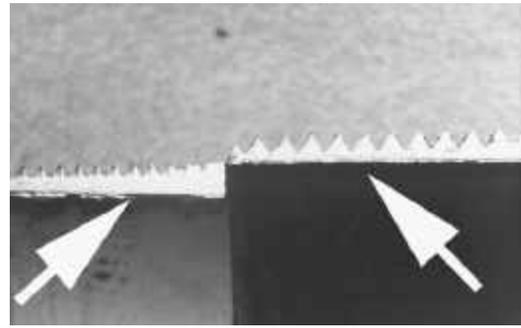
Figure 6

comparison of the cross section of two pipe nipples. The pipe nipple to the right has an improperly manufactured thread where the thread depth is nearly 70% of the wall thickness. The pipe nipple shown by the left arrow is one of acceptable manufacture where the thread depth may be less than 30% of the total wall thickness. Due to the excessive thread depth the pipe nipple on the right failed at a very low load, causing water to cascade down several stories in a high rise building, resulting in a costly loss.
