Antique Vehicle Fire Losses

By Charles C. Roberts, Jr., Ph.D., P.E.

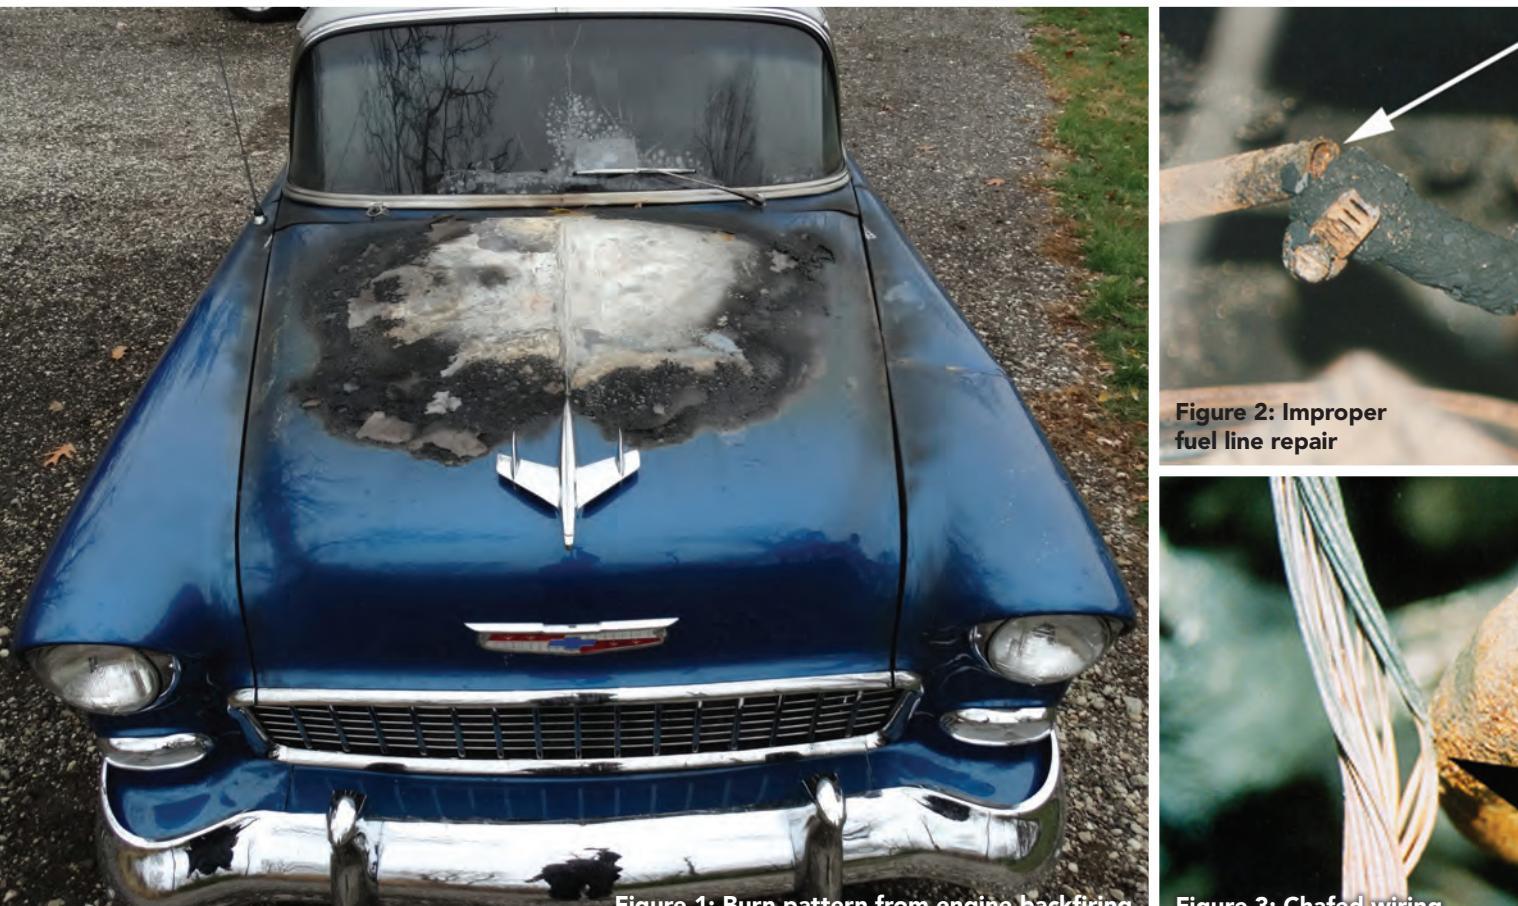
Figure 1: Burn pattern from engine backfiring

Figure 1 shows a burn pattern on a 1956 Chevrolet that was a result of backfiring.

This is the condition when the fuel/air mixture is ignited when the intake valve is open, resulting in fuel and flame being ejected into the air filter housing. A fire typically spreads throughout the engine compartment, causing severe damage. Backfiring is a result of an ignition problem, either because of a lack of maintenance or an improper tune-up of the vehicle. If an automotive shop had tuned up the vehicle recently, then they may be responsible for the deficiencies in tuning the vehicle and the backfiring.
