Wheel Detachment: Improper Spindle Nut Installation

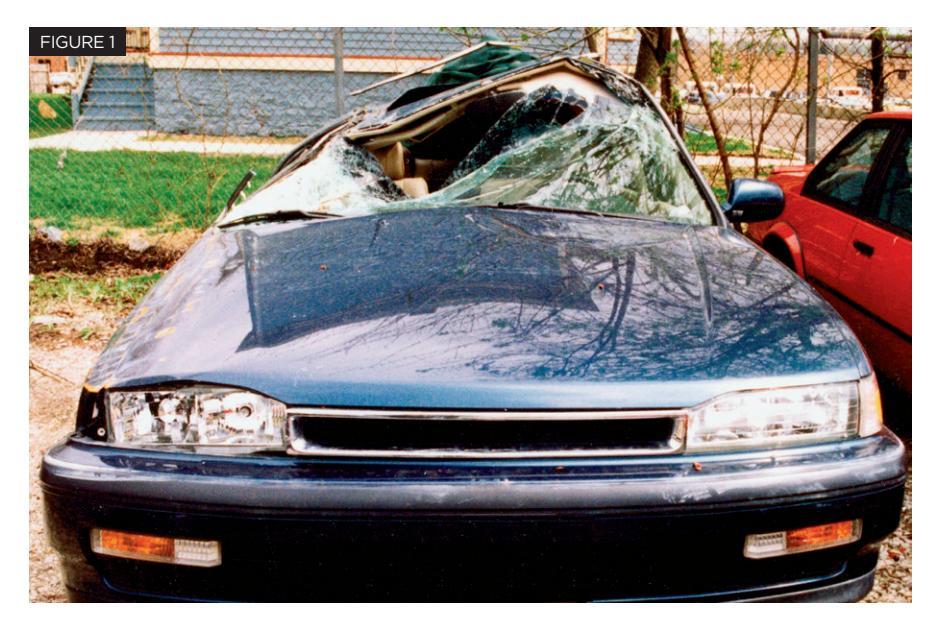
etermining the cause of an automobile accident is often encountered by the claims analyst. Was the accident a result of driver error, actions by another party or a mechanical failure of the vehicle? Detachment of a wheel from a vehicle, which is the subject matter of this case study, is known to cause severe accidents. **Figure 1** shows the result of wheel detachment which caused a vehicle to roll over with severe injuries suffered by the occupants. The left front wheel became detached, causing loss of control of the vehicle. **Figures 2a & 2b** are views of a typical wheel spindle which secures the wheel, bearings and hub to the vehicle. A castle nut (also called a castellated nut or slotted nut) with cotter pin is used to secure the wheel hub to the vehicle. (**Figure 2a**)

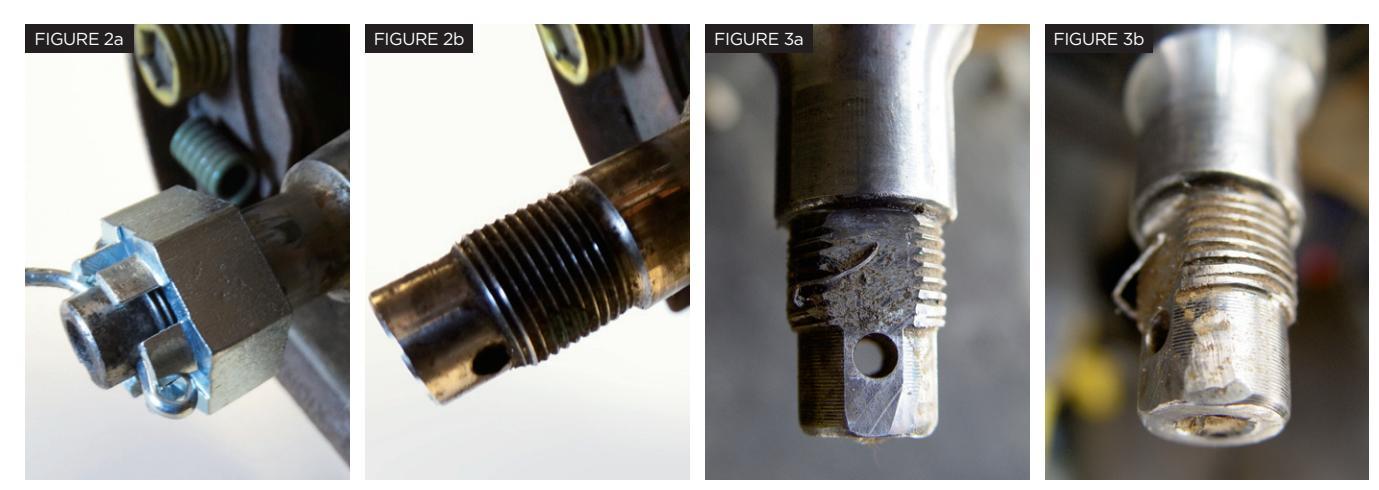
Figures 3a & **3b** show photos of the spindle from the left front of the vehicle in **Figure 1**. The hub, castle nut and cotter pin were not connected to the spindle after the accident. Deformation pat-

terns on the spindle nut threads show evidence of wear (including one separated thread that has sheared from the spindle), consistent with the nut working outboard and becoming disengaged from the threaded section of the spindle. This suggests that no cotter pin had been installed or that the cotter pin had been improperly installed.
