Down Goes the Tractor

By Charles C. Roberts, Jr., Ph.D., P.E.

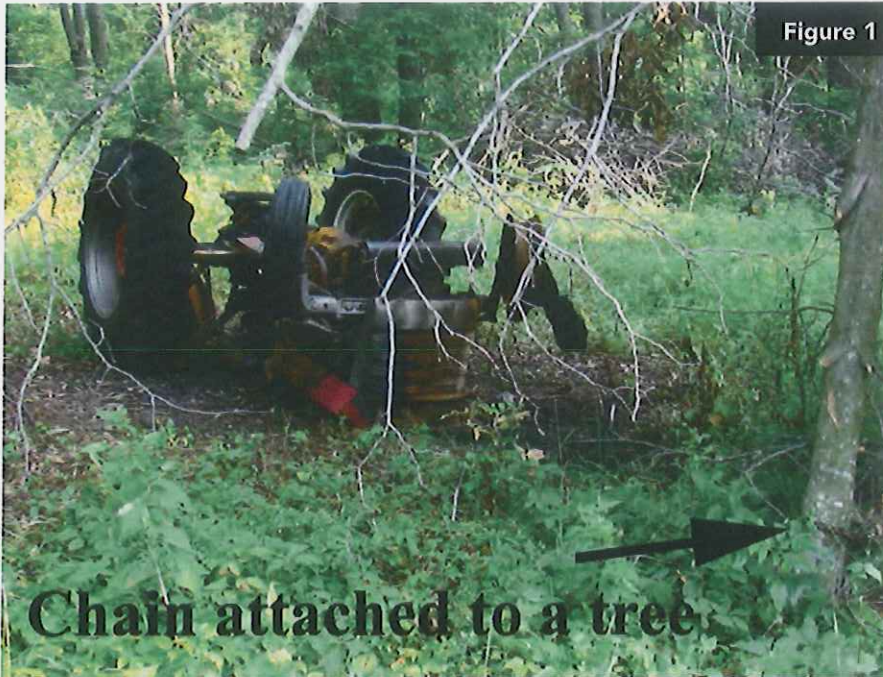
ACCORDING TO THE UNITED States Department of Labor, 44% of farm accidents are due to tractor rollovers. The National Agricultural Tractor Safety Initiative reports that tractors cause about 130 deaths annually — or half of all farm-worker fatalities. This case study deals with a common type of tractor upset where the tractor ends up upside down. Figure 1 shows the tractor at the accident scene. The tractor was being operated for

pulling down a tree with a chain attached to the tractor body and the base of a tree. While performing this task, the tractor turned over, ejected the driver and caught fire, resulting in a fatality.

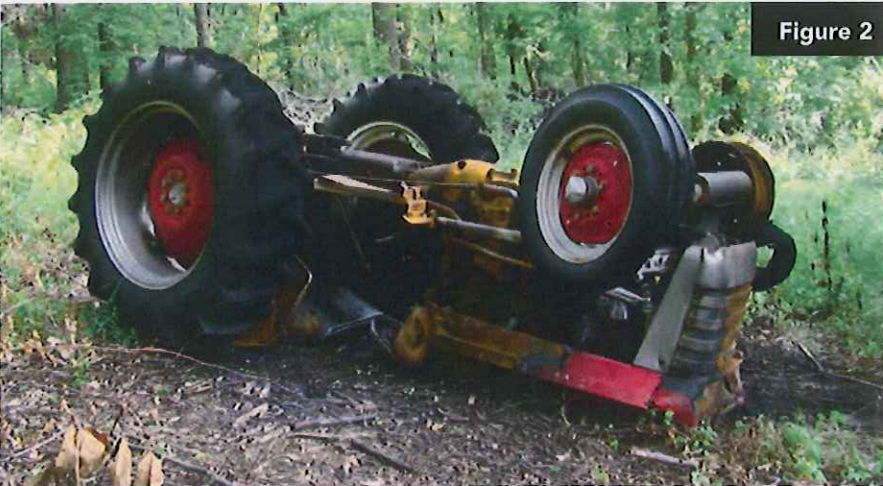
Figure 2 is a close-up of the tractor showing burned areas as a result of volatile liquids, such as oil or gasoline, contacting hot exhaust components after being expelled as a result of the tip-over.

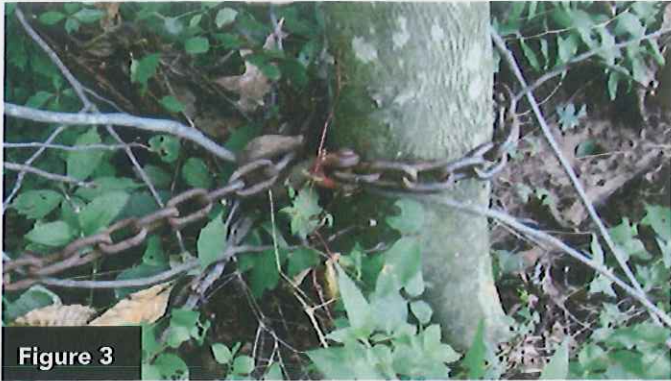
Figure 3 shows the chain attached to

the tree that was being removed. Figure 4 shows the location on the tractor where the chain was attached. The attachment was high above the rear axle near the driver's seat at a three-point hitch upper fitting.

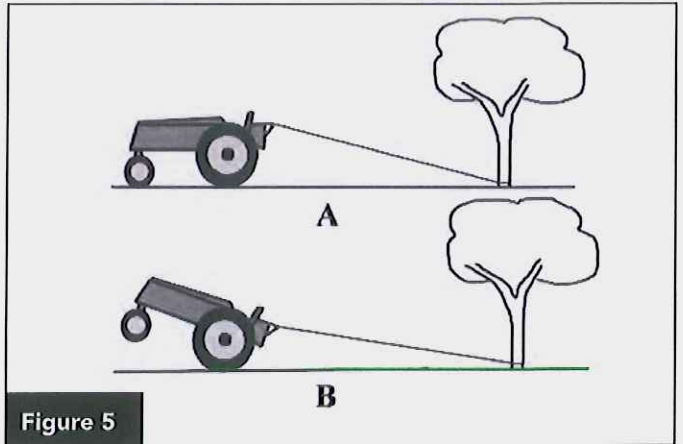
Figure 5 depicts the probable scenario regarding this accident. The chain is attached to a point high above the rear axle of the tractor as shown in Figure 5A. As the tractor pulls on the chain where the resistance is high, the front of the tractor can "rear up" as shown in Figure 5B. Since farm tractors have a very low first gear, there is sufficient torque available to actually lift the front of the tractor and tip over toward the rear when the resistance to pull is very high, as in this case. This tractor had a fixed throttle, so it continued to operate, despite the operator falling off the vehicle.

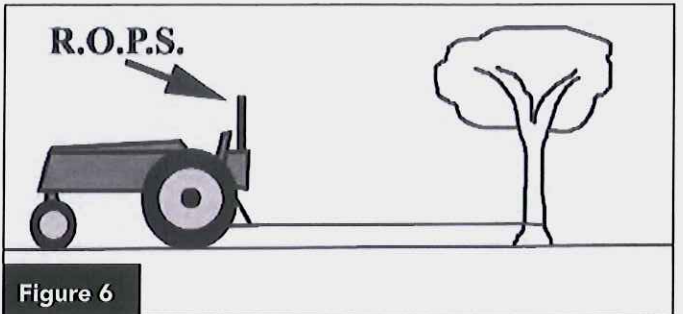
Figure 6 shows the proper way to apply a pull load to a tractor. The hitch is below the axle which applies a torque that keeps the tractor front on the ground. If the load is excessive, the rear wheels merely spin without turning over the tractor. A roll-over protective structure (R.O.P.S.) may have helped in this case but was not standard equipment on older tractors. Most modern small farm tractors are equipped with a roll-over protective structure. The root cause of the accident was improper usage of a farm tractor.
