Claims[®]

Agricultural Accidents

Charles C. Roberts, Jr.; Ph.D., P.E.

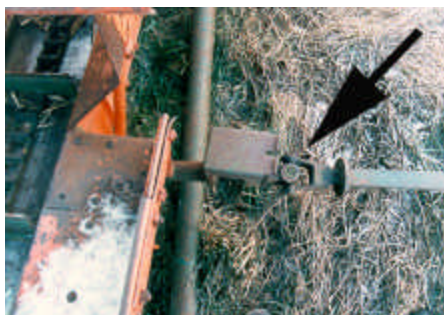
Figure 1 is a view of a power take-off (PTO) shaft on a 1950's vintage elevator that was

purchased used by the owner. While the machinery was being operated, a worker's clothing became entangled in the universal joint, resulting in severe injury. Figure 2 is the manufacturer's parts list for the elevator showing the existence of a guard that would

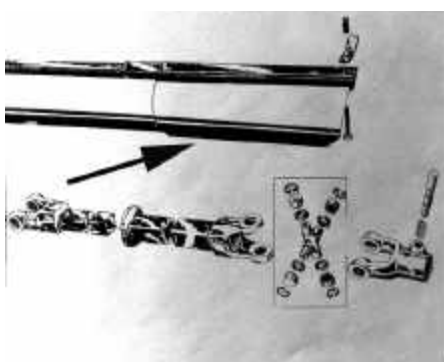
Figure 2

probably have prevented the injury. Absence of guards is often a significant factor in entanglement accidents.

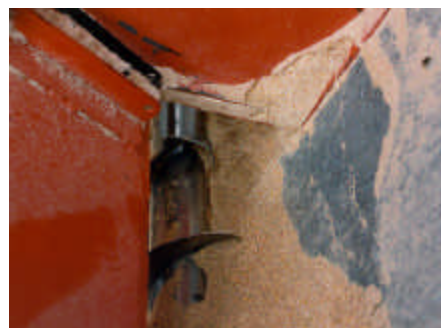
Figure 3 is a view of an auger that was at the bottom of a grain cart. During unloading operations, a laborer tried to free clogged grain in the auger chute. The laborer slipped and lost part of his foot when it was sheared off at one of the auger flutes. Augers of this type do not have internal guards since they would interfere with grain flow. The auger, however, is in a place difficult to access by laborers during normal operation. This is called guarding by position. The difficulty occurs when laborers engage the point of operation without turning off the machine.

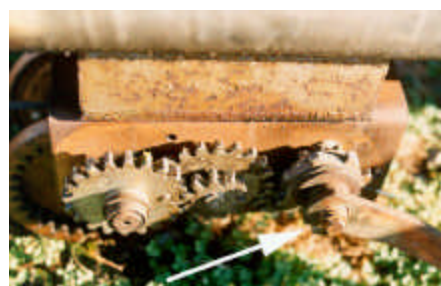
Figure 4 is a view of a grain auger winch that failed while the auger was being raised. The washer on the crank handle was too

small, allowing the handle to come loose. This defeated the ratchet mechanism and allowed the auger to suddenly fall, killing one of the workers. This was a result of an improper repair to the mechanism.

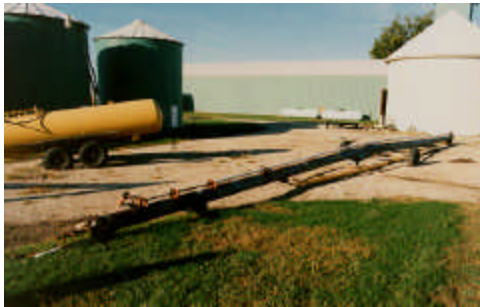
Figure 5 is a view of an auger that was being raised at the time of the accident. This auger did not have a stop to prevent it from being raised too high. During the raising, the landing gear lift slide traveled beyond center, causing instability and the collapse of the auger, injuring a worker. This was a design defect.

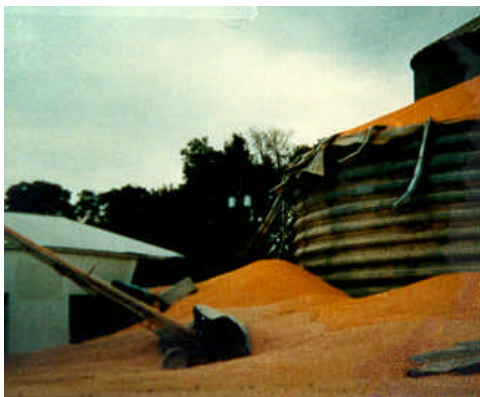
Figure 6 is a view of a failed grain bin. The loss includes the grain bin and crop. An improperly designed sidewall failed, causing the grain to be spilled and injury to workers.

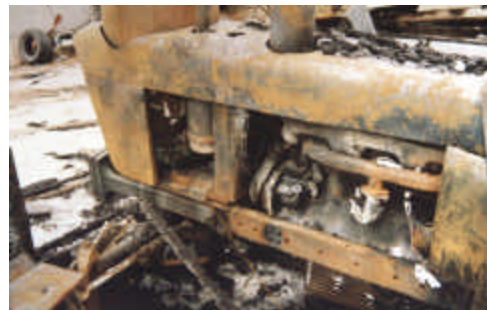
Figure 7 is a view of a burned farm tractor inside a barn. Immediately prior to the fire, a mechanic was attempting to fix an ignition problem with the propane fueled tractor. Some spark plugs were out of the vehicle while the mechanic was diagnosing the

spark. The vehicle was being turned over by the starter motor, resulting in propane entering the barn and being ignited by the sparking wires.

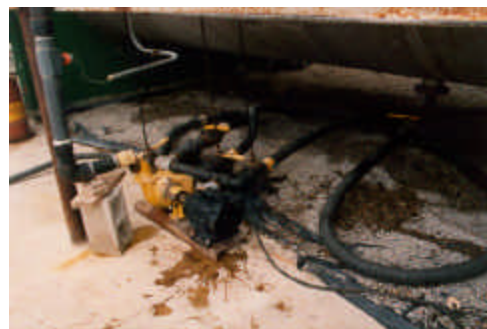
Figure 8 is a view of a pumping system that allowed herbicide to mix with fertilizer. The system had not been properly flushed. Consequently, when the fertilizer was applied, significant crop loss resulted.
