A special reprint from

Analysis of Clothes Dryer Fires

Charles C. Roberts, Jr., Ph.D., P.E.

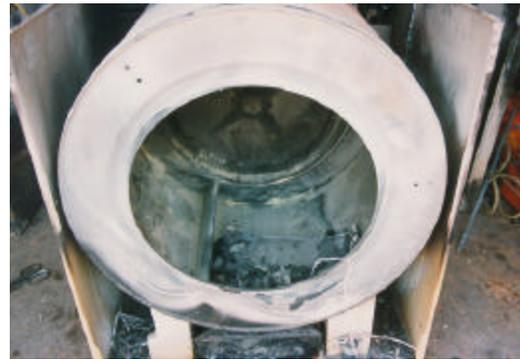
Figure 3 is a view of a gas dryer with a relatively low burn pattern in the vicinity of the

burner. Figure 4 is a view of one of the temperature limit switches that had parted from its mount. The small plunger that was a part of the limit switch had fallen out (Figure 5),

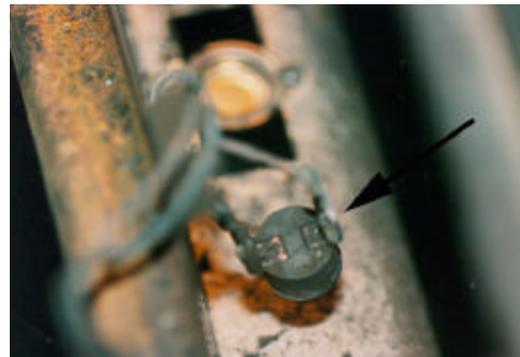
Figure 4

rendering the high temperature limit function ineffective. This resulted in overheating, causing the fire. This appears to be a manufacturing related deficiency. Figure 6 is a view of a gas dryer that caught fire shortly

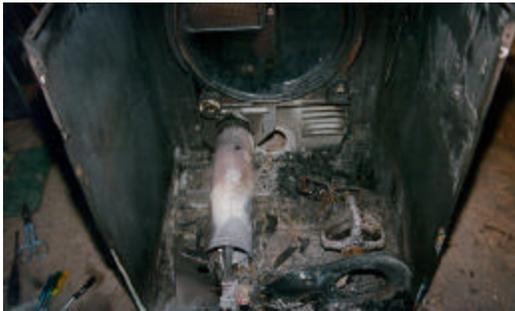
Figure 6

after the owner heard a scraping sound. Figure 7 is a view of a failed support bearing which caused the drum to wobble and scrape the back of the dryer. This opened a gap between the drum and dryer housing, resulting

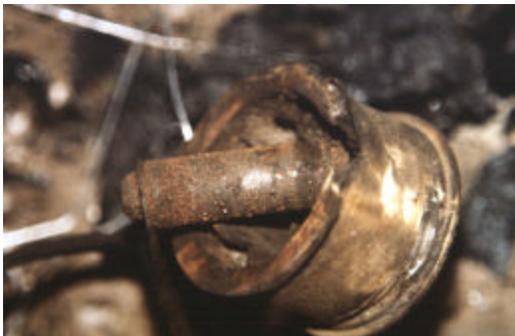
Figure 7

in clothes falling out of the drum onto the bottom of the dryer.

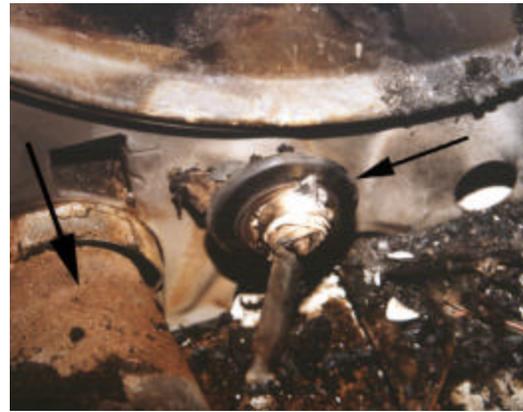
Figure 8 shows clothing tangled in the other support roller as shown by the right arrow and clothing contacting the burner shroud as shown by the left arrow. The bearing failure appears to be an end of useful life failure, as the dryer is old.

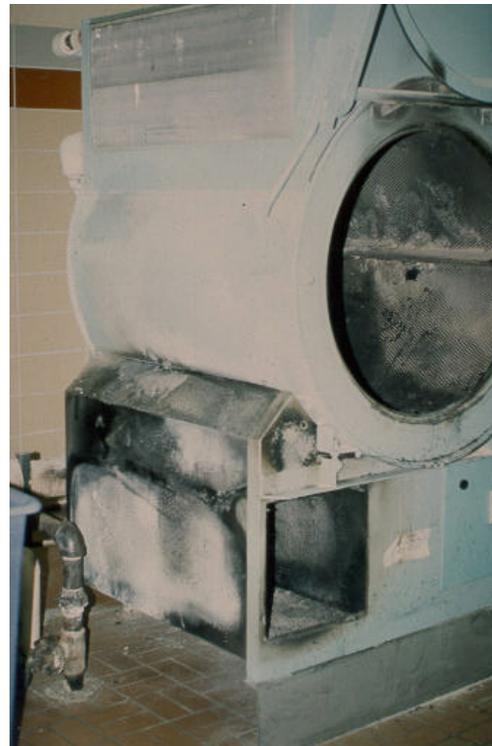
Figure 9 is a view of a large industrial dryer that sustained a fire in the vicinity of the air circulating impeller, which was constructed of a magnesium alloy (Figure 10). The magnesium alloy had ignited and had to be

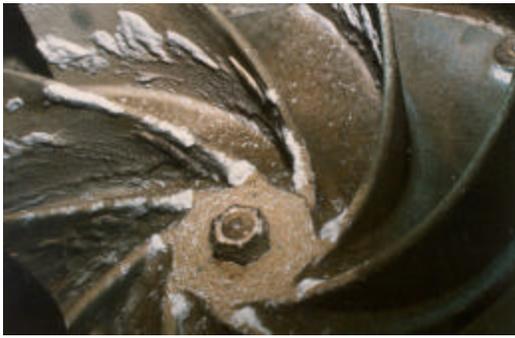
Figure 10

extinguished with a chemical agent. The impeller was partially consumed, yet one interesting piece remained. In Figure 11 we see a lump of magnesium with a bent paper clip lodged inside. Scrape marks on the paper clip suggest that it became engaged in the

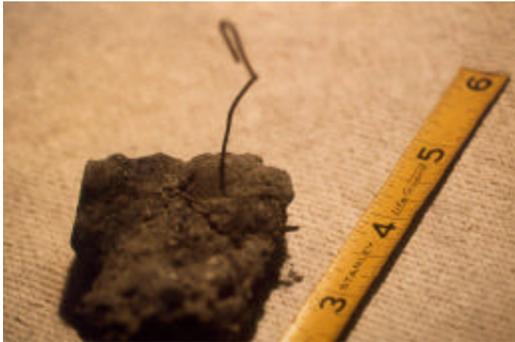
Figure 11

gap between the rotating impeller and shroud, causing frictional heating that ignited the magnesium.
