Explosions Caused by Leaks in Flexible Gas Connectors

Charles C. Roberts, Jr., Ph.D., P.E.

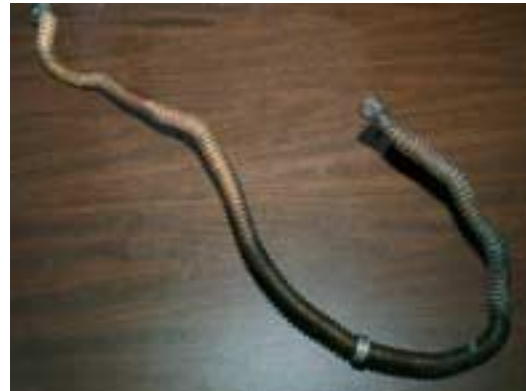
Environmentally assisted cracking (stress corrosion cracking) occurs in certain types of brass used in flexible connectors. Figure 1 is a view of a typical flexible gas connector. Figure 2 is a view of a crack in a flexible

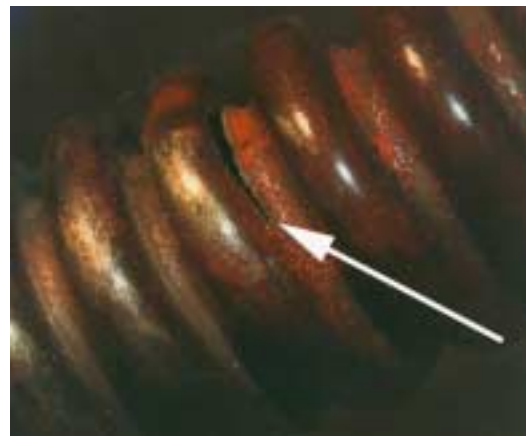
Figure 2

connector caused by environmentally assisted cracking. The crack is in a stressed section of the tube. Chemical analysis of the brass showed it to be Cartridge Brass (nominally 70% copper and 30% zinc). Brasses containing more than 20% zinc are highly susceptible to stress corrosion cracking. Figure 3 is a photomicrograph of a cross-section of the tube showing the grain structure of the brass and severe intergranular corrosion in the tube, characteristic of stress corrosion cracking. The corrosion is aggravated by household cleaning chemicals such as ammonia. The cracking can occur with very little movement of the tube and is often a subtle failure.
