Failure Analysis of Grain Bins

Charles C. Roberts, Jr. Ph.D., PE

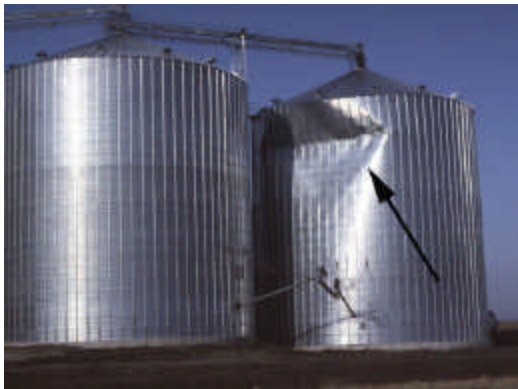
Figure 1 is a view of buckling of a side wall of a grain bin. This happened during a wind storm when the bin was empty. Many bin designs rely on the bin being full to generate hoop tension in the side wall. This keeps the bin round, thereby maximizing the resistance to wind loads. In some designs, side wall stiffeners are under-designed, causing side wall failures at very low wind loads.

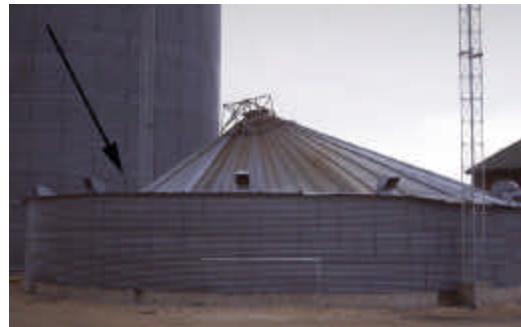
Figure 2 is a view of a roof failure on a grain bin. This occurred from excessive fan pressure generated during forced ventilation in the winter. The lower air intakes on the bin were clogged by frost, resulting in a high negative pressure inside the bin and collapse of the roof. It is not unusual for ventilation to generate sufficient pressure to cause a grain bin roof to fail. Figure 3 is a view of another bin roof failure due to winds clocked at 90 MPH. The fans were not operational but the bin was nearly full. Wind deflections on a grain bin roof

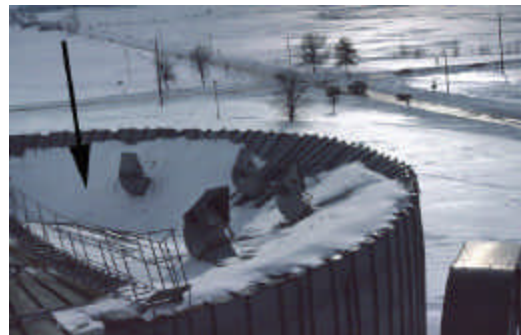
Figure 3

often tend to depress the roof on the windward side and lift the roof on the leeward side.

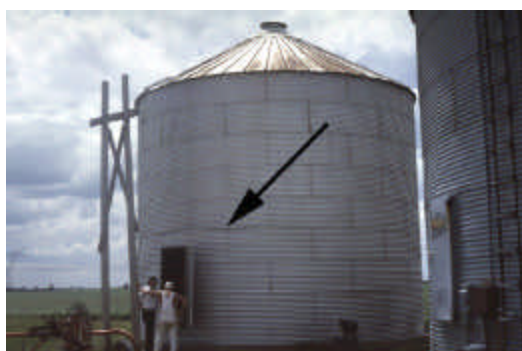
Figure 6 is a view of a side wall of a bin that buckled due to side unloading. A chute was cut in the side of the bin for side discharge which placed an unsymmetrical and damaging load on the bin. Most manufacturers discourage side discharge for this reason.
