Failure Analysis of Grain Bins

Charles C. Roberts, Jr. Ph.D., PE

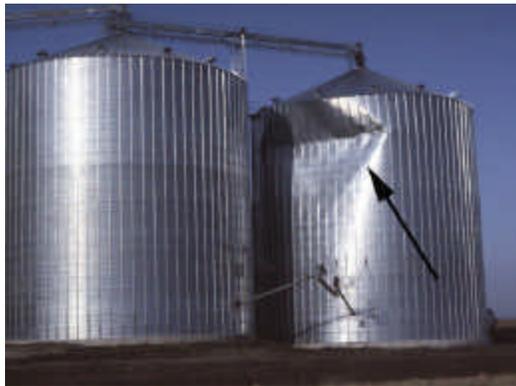
Figure 1 is a view of buckling of a side wall of a grain bin. This happened during a wind storm when the bin was empty. Many bin designs rely on the bin being full to generate hoop tension in the side wall. This keeps the bin round, thereby maximizing the resistance to wind loads. In some designs, side wall stiffeners are under-designed, causing side wall failures at very low wind loads.

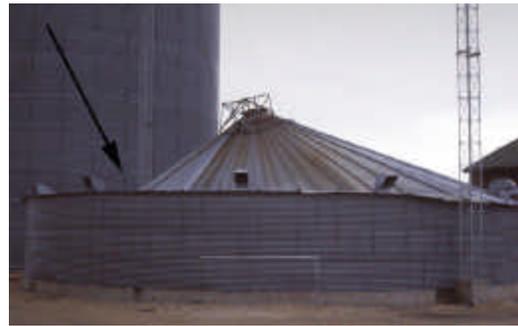
Figure 2 is a view of a roof failure on a grain bin. This occurred from excessive fan pressure generated during forced ventilation in the winter. The lower air intakes on the bin were clogged by frost, resulting in a high negative pressure inside the bin and collapse of the roof. It is not unusual for ventilation to generate sufficient pressure to cause a grain bin roof to fail. Figure 3 is a view of another bin roof failure due to winds clocked at 90 MPH. The fans were not operational but the bin was nearly full. Wind deflections on a grain bin roof

often tend to depress the roof on the windward side and lift the roof on the leeward side.

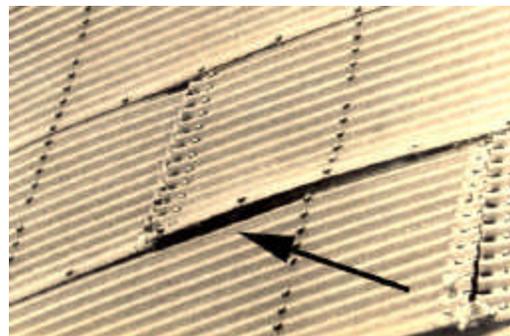
Figure 4 is a view of a failed side wall in a large bin. Close inspection of the side wall indicated that the bolts were loose. Tests indicated break away

torque readings well below the manufacturer's recommendations. This is a result of deficient construction of the bin. Figure 5 is a view of a deformed internal side wall stiffener resulting from improper bolt torque.

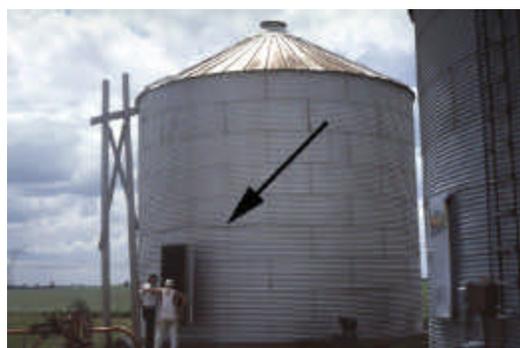
Figure 6 is a view of a side wall of a bin that buckled due to side unloading. A chute was cut in the side of the bin for side discharge which placed an unsymmetrical and damaging load on the bin. Most manufacturers discourage side discharge for this reason.
