Lumber Defects and Roof Frame Failures

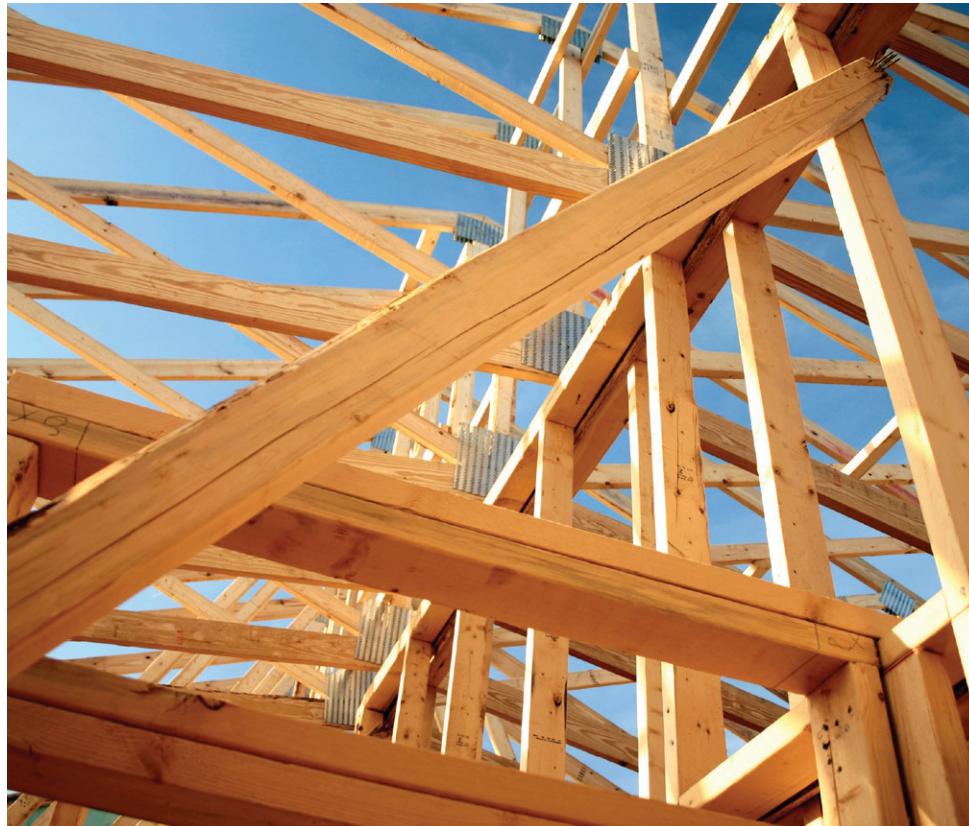
Figure 1 shows a roof rafter failure brought on by a large knot that encompassed about half of the cross section of the board. The knot extended from the center all the way to the lower edge or tension side of the joist. The knot had not adhered well to the surrounding wood and a crack developed along the circumference of the knot. Since the crack entered the tension side of the joist, it propagated from the lower edge, resulting in severe reduction in strength. This left half of the cross section of the board supporting the load.
