Claims[®]

January
2018

Masonry Wall Cracks: Shelf Angle Failure

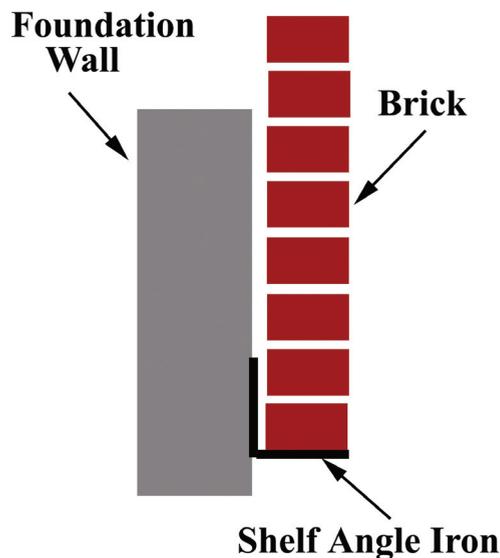
▲ Figure 2

Figure 2 reviews the concept of the shelf angle support typically used in the construction of residential brick walls. The angle iron is secured to the foundation wall to support the weight of the masonry veneer wall. This transfers the weight of the veneer wall to the foundation, which can support the load without significant deflection when the foundation is designed properly.
