Small Worm-Style Hose Clamp Failures in Automotive Applications

Charles C. Roberts, Jr. PH.D., P.E.,
C. Roberts Consulting Engineers, Inc.
2090 Brush Grove Road
Rochelle, IL 61068 USA
www.croberts.com

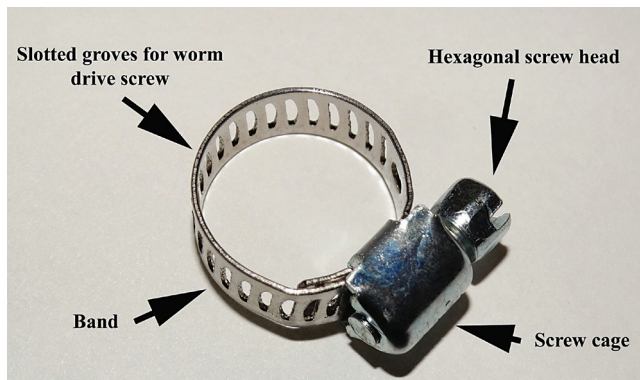
What is typically done with a leak at a small worm-style (worm gear) hose clamp? Just keep tightening it until the leak stops! **Figure 1** is the anatomy of the small worm-style hose clamp. The over-torquing of small worm-style hose clamps can lead to serious problems. Proper torque is around 10 to 15 in-lb, but rarely does anyone actually use a torque wrench to apply the clamp.

Fig. 1 — anatomy of the small worm-style hose clamp.
