Claims[®]

Shedding Some Light on Auto Accidents

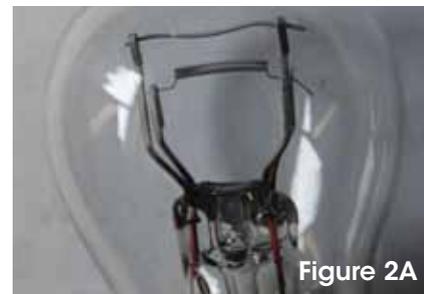
Figure 2A

In Figure 2A, the bulb is a standard sealed beam 1157 bulb found in many tail light assemblies. Figure 2B is a bulb extracted from the rear impact area of a vehicle. The bulb was not fractured, but the filament, as indicated by the arrow, is severely deformed.

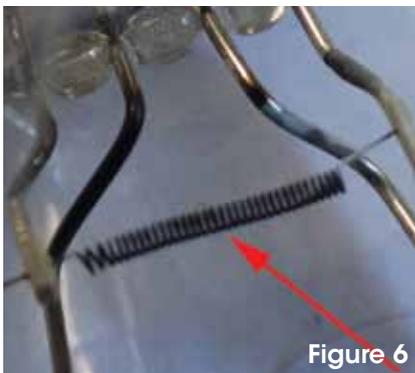
Figure 6

In some incidents, the glass fractures and the filament remains intact, but is heavily oxidized. The oxidized tungsten surfaces are a result of high temperatures, indicating that the filament was incandescent at one time after the glass fractured.

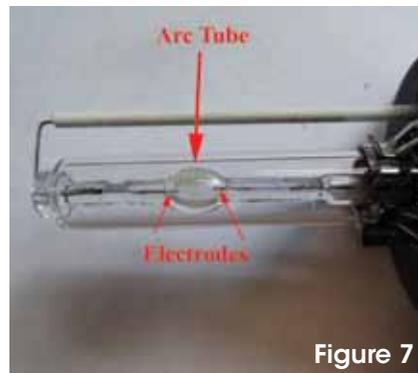
Figure 7

Figure 7. The bulb contains an arc tube with electrodes. The arc tube contains xenon gas, mercury and metal halide salts. When voltage is applied, an arc develops providing a bright light.
