# Claims<sup>®</sup>

May  
2018

# Shedding Some Light on Auto Accidents

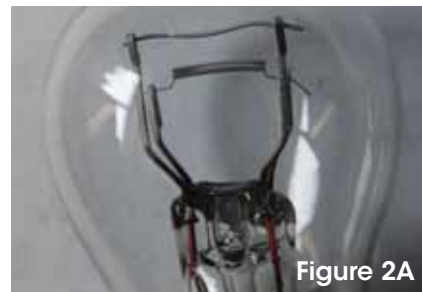
Figure 2A

In Figure 2A, the bulb is a standard sealed beam 1157 bulb found in many tail light assemblies. Figure 2B is a bulb extracted from the rear impact area of a vehicle. The bulb was not fractured, but the filament, as indicated by the arrow, is severely deformed.

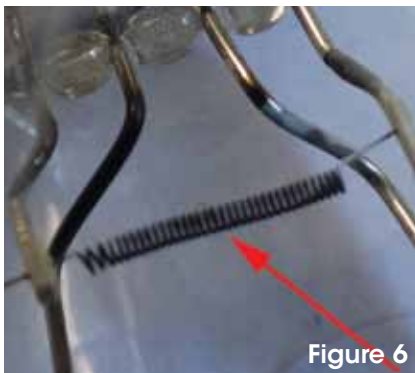
Figure 6

In some incidents, the glass fractures and the filament remains intact, but is heavily oxidized. The oxidized tungsten surfaces are a result of high temperatures, indicating that the filament was incandescent at one time after the glass fractured.

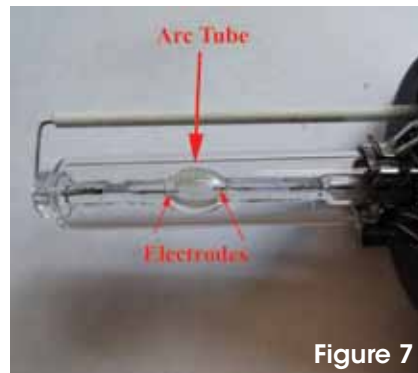
Figure 7

Figure 7. The bulb contains an arc tube with electrodes. The arc tube contains xenon gas, mercury and metal halide salts. When voltage is applied, an arc develops providing a bright light.

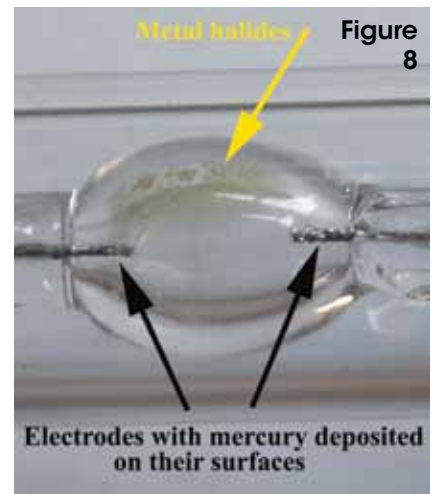
Figure 8 is a close-up of the arc tube on a new lamp. The metal halide salts have a yellowish color as indicated by the yellow arrow above the arc tube. While in operation, the metal halide salts are vaporized and distributed throughout the arc tube. If the arc tube is fractured from the accident, then these gaseous components escape. Upon cooling, there is very little evidence of deposits on the inside of the fractured arc tube, which suggests the light was on at the time of impact.

Oxidized electrodes (greyish blue in color) and/or ductile deformations are also an indicator that the light was on at the time of impact. Figure 8 also shows mer-

cury deposits on the electrodes of a new lamp. If the lamp is powered at the time the arc tube is fractured, mercury escapes and there is little left on the electrodes.
