Automobile Seat Failure

By Charles C. Roberts, Jr., Ph.D., P.E.

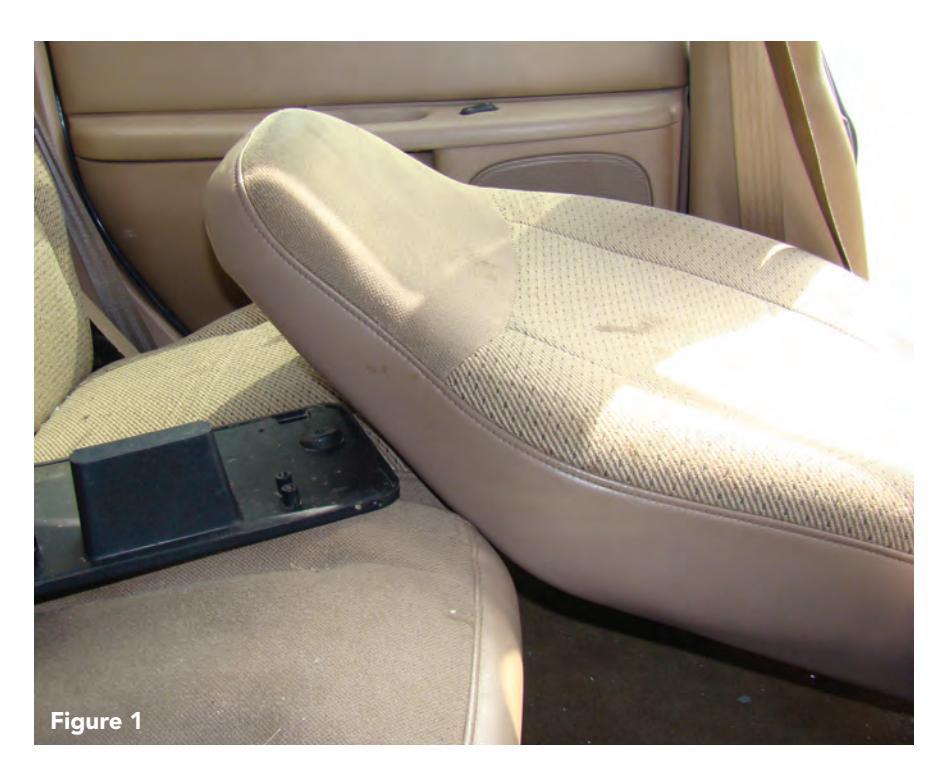
According to the insured, he was driving on a straight road during the day, with good weather conditions, when the driver's seat suddenly collapsed backward, causing him to lose control of the vehicle, which ended up in a ditch. Examination of the vehicle resulted in the photo in Figure 1 showing the driver's seat collapsed onto the back seat.

arrow points to a bolt that had failed, releasing the upper attachment to the seat frame from the seat recliner bracket. This will cause the seat to fall back until stopped by whatever is in the back seat. In this case, the seatback reclined all the way to the back seat cushion as shown in Figure 1.

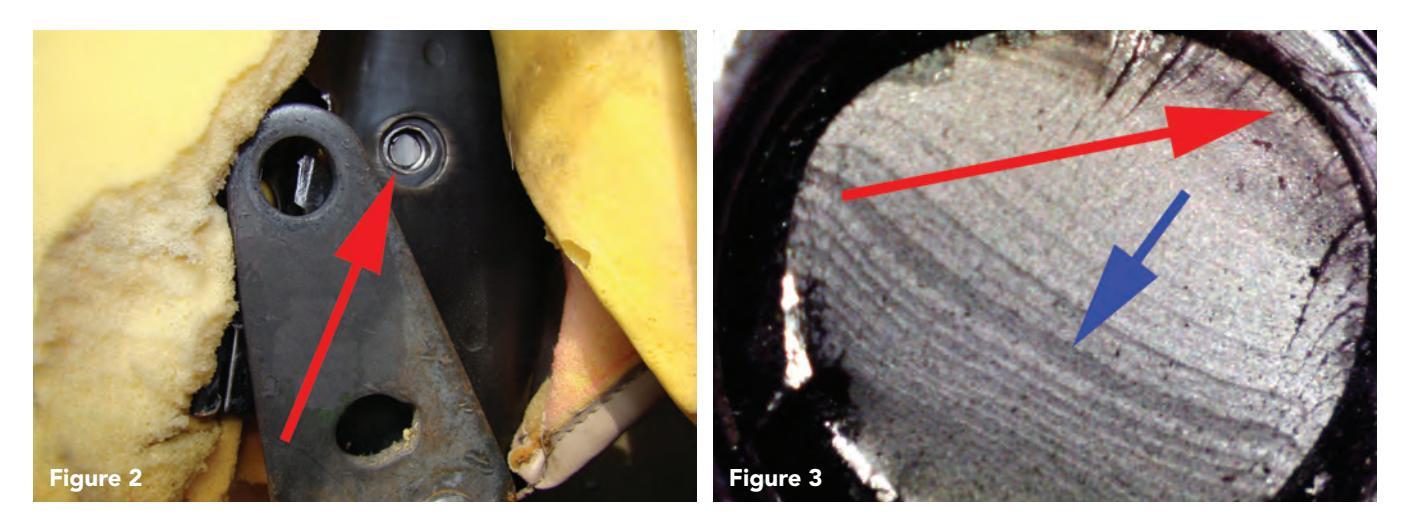
Figure 2 is a view of the driver's seat support bracket on the left side. The red

This failure is addressed in a manufacturer's recall that required dealers to replace this system with a bolt and metal spacer. The metal spacer reduces the rocking motion of the bolt that would essentially eliminate the bending fatigue. It does not go unnoticed that this loss was caused by a design defect, which can be a basis for subrogation.
