Fires Resulting from Low Water Cutoff Control Malfunctions

Charles C. Roberts, Jr., Ph.D., P.E.

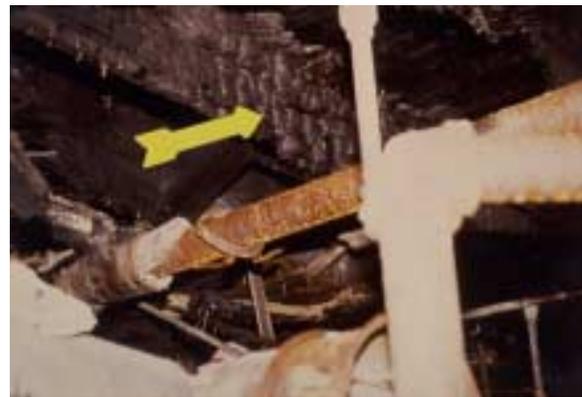
lower portion is unscathed. Figure 2 shows the deepest char depth, which is just above the boiler toward the flue end, a place expected to be quite hot from an overheating boiler. This particular boiler had a float type low water cutoff control. Electrical measurements were performed on all controls.

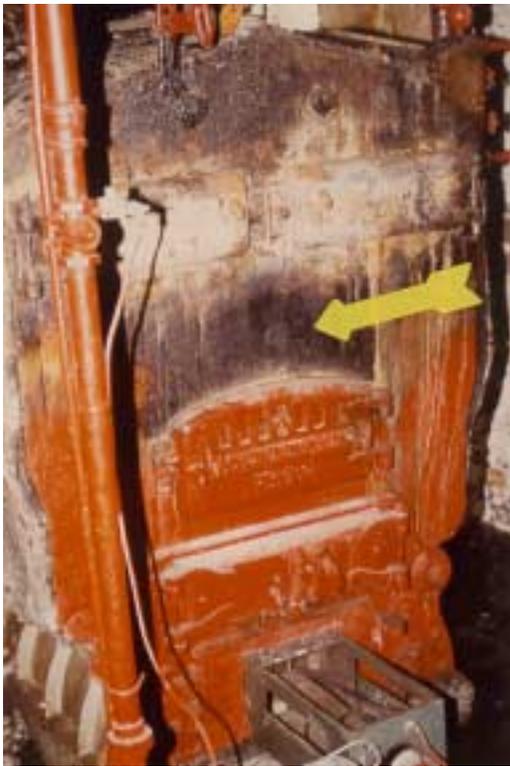
materials such as wood joists in the boiler room. Figure 1 shows a boiler that has experienced overheating. Burn patterns are severe on the top side of the boiler while the

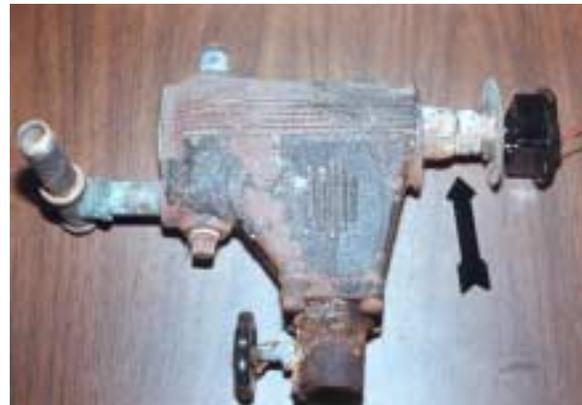
Testing indicated that the low water cutoff control was still signaling the burner that the water level was within limits yet there was no water in the boiler. This testing was performed with the control on the boiler. Figure 3 shows the low water cutoff after removal from the boiler. Notice the severe sludge deposits inside the control as shown by the arrow. This prevented the float from descending and opening the circuit to the burner. After the control was cleaned it worked properly. The probable cause of this fire was lack of maintenance causing a low water cutoff control to malfunction. The manufacturer of this control installed a warning tag on the unit stating that the operator should blow down (clean out) the control every week. It appeared that this had not been done for several months. The system had no water treatment apparatus installed.

If a malfunction of the boiler is suspected, DO NOT remove the boiler controls until they are tested in place. A slight movement of a sticky low water control can cause it to return to an operational condition resulting in loss of important evidence. The remaining controls should also be tested to rule out any additional or aggravating causes such as a malfunctioning gas valve or temperature limit device.
